Fix an iPhone XS with no service

This guide will help you fix an iPhone XS with no service.

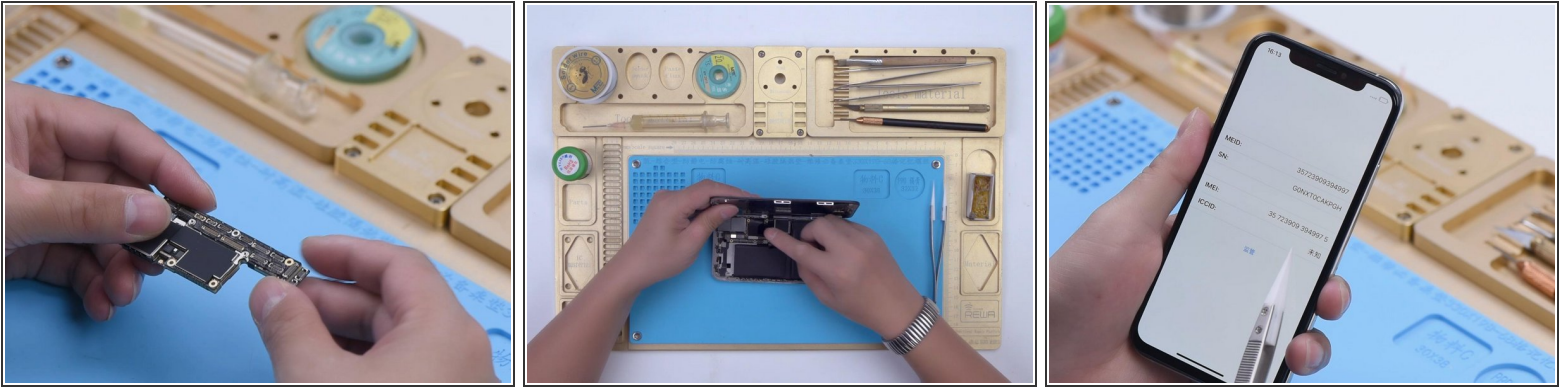
Step 1 — Fix an iPhone XS with no service

- The phone had no service after being dropped and couldn't be activated after a system upgrade. Firstly, inspect the appearance of the motherboard. The motherboard is not deformed or water damaged.
- Then we install the motherboard on the phone to test. Connect the display and battery. Insert the SIM card. The phone can be turned on. However, the ICCID is not showing, which indicates that the SIM card is not read.

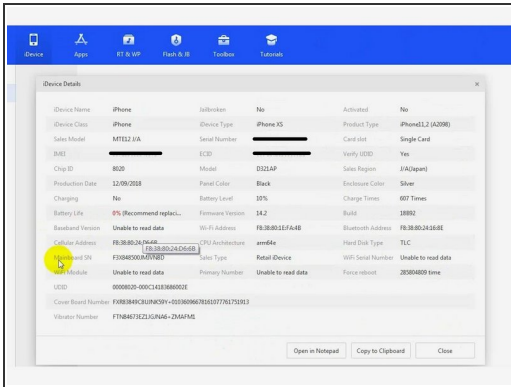
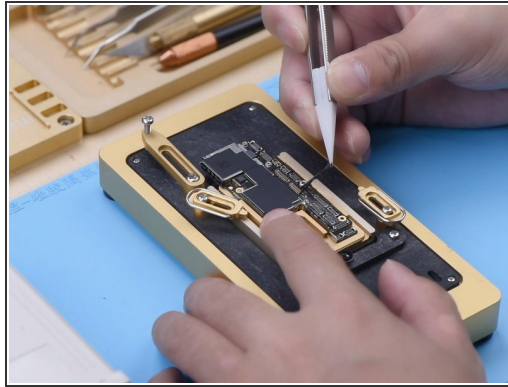
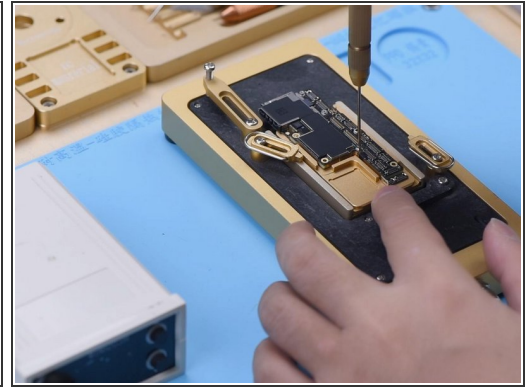
Step 2

- Connect the phone to the computer. Open 3uTools and view device details. 3uTools is unable to read data of the baseband version and Wi-Fi module.
- Because the phone had no service after being dropped. It can be preliminarily judged that the pseudo-soldering of the middle layer may cause the trouble. Next, we need to separate the motherboard. Put the motherboard on the Heating Platform and peel off the foam.
- To make it easier to remove the logic board after separation, drive a screw on the logic board. Cut through the tape with a sculpture knife.

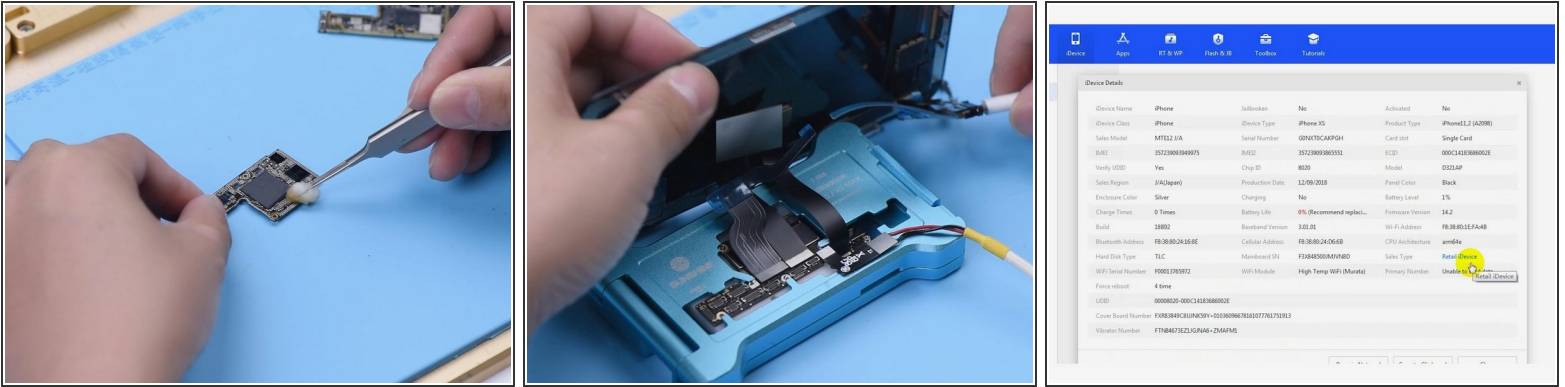
Step 4

- Clean the logic board with PCB Cleaner and remove the screw. Clean the signal board with PCB Cleaner.
- Attach the signal board and logic board to the Testing Fixture. Connect the screen to the motherboard with a Test Extension Cable. Connect the charging port flex cable and power cable. Then turn the phone on by connecting it with the computer.
- Open 3uTools and view device details. The baseband version and Wi-Fi module can be read. It can be confirmed that the pseudo soldering causes the absence of the baseband version.

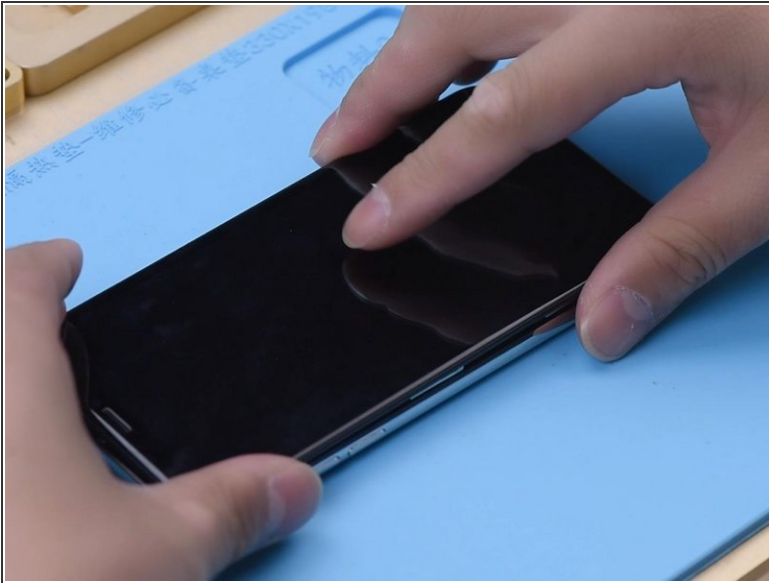
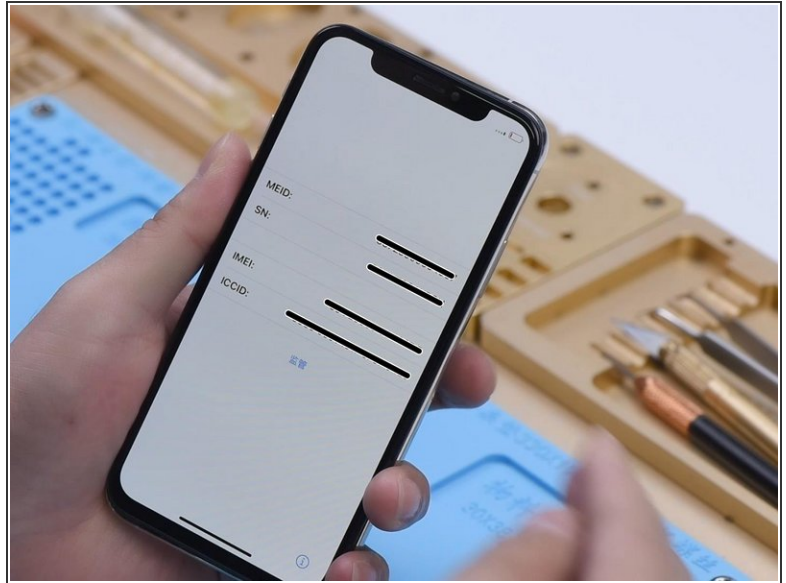
Step 7

- After recombination, install the motherboard on the phone. The phone can be turned on. Insert the SIM card. ICCID is showing. Because the phone has a network lock and we don't have a SIM card of the carrier. No further tests can be conducted.

The iPhone XS had no service after being dropped. 3uTools couldn't read the baseband version when we connected the phone to the computer. Through motherboard separation and testing the phone on the testing fixture, we confirmed that the no service trouble was caused by the pseudo soldering of the motherboard middle layer. ICCID came back to normal and the fault was cleared after we recombined the logic board and signal board.
