# Marshall Monitor Headset Audio Cable Repair

Written By: Albertine Carabine

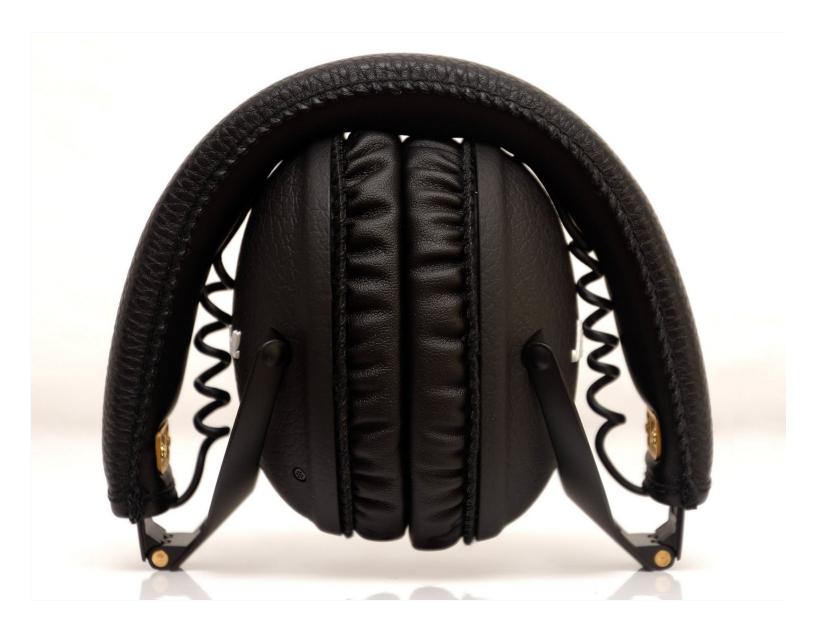
Under conditions of repeated use, the cable connecting the left and right Marshall headphones ends up breaking one one or both sides as a result of stress at the point where it enters the headphone caused by folding them. As a result, audio output will be reduced to a single ear.

This guide teaches you how to repair the damaged part of the cable in order to regain the use of the stereo. It will take dexterity, a soldering iron, and a little patience.
