How to Reattach the Support Bracket in a Hamilton Beach 2-Slice Toaster

Repair the support bracket in your toaster, and make your toaster fully functional again.

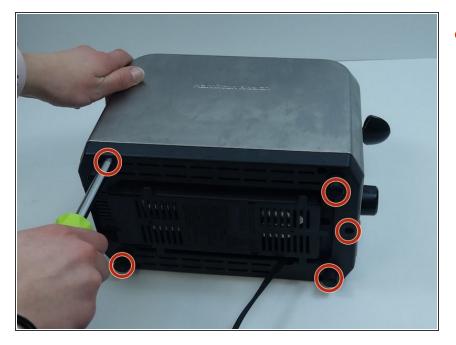
Step 1 — How to Reattach the Support Bracket in a Hamilton Beach 2-Slice Toaster

Remove all five 5mm Phillips #1 screws from the bottom of the toaster.

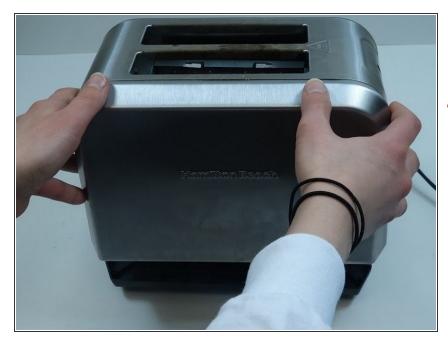
Step 2

• Lift the top of the toaster from the bottom section of the toaster.

Do this carefully so that you don't damage the switch board.

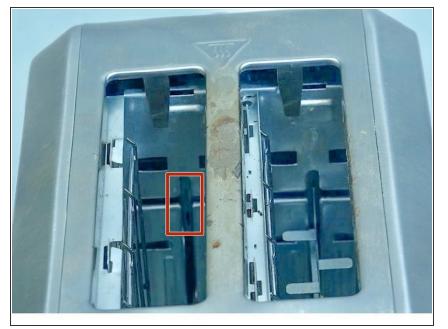
Step 3

• Look into the toaster and locate the two divots that the support bracket has detached from.

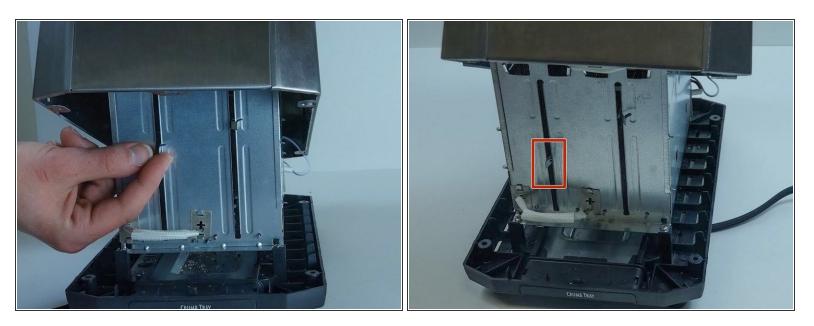
Step 4

- Locate the detached support bracket.
- (i) From the back of the toaster (the side opposite the side of the toasting lever), you will see the broken support bracket sticking out.

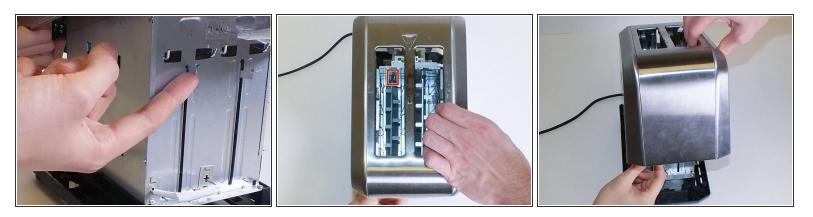
Step 5

- Use the portion of the bracket that is sticking out of the back of the toaster to move the support bracket.
- Align the support bracket with the two divots on the moving bracket assembly.
- (i) In this particular model, the shell of the toaster cannot be completely removed. It might be helpful to have a helper hold up the shell of the toaster so that it is not in your way.

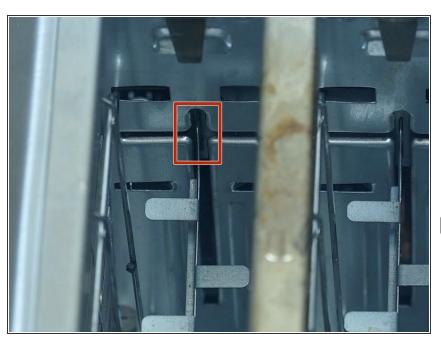
Step 6

- Using moderate force, push the teeth of the support bracket into the divots on the moving bracket assembly.
- If the teeth on the support bracket are damaged, further repair might be necessary in order for them to fit into the divots.

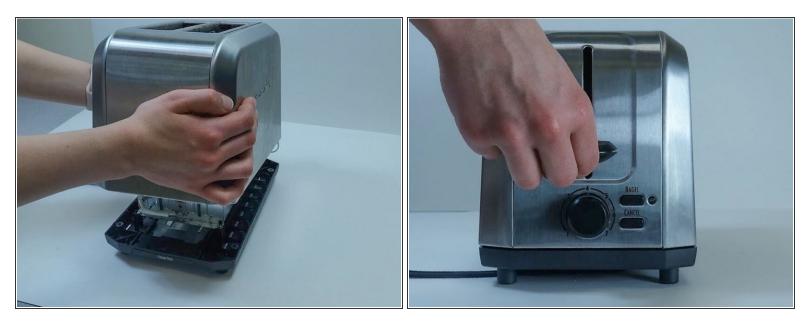
Step 7

- Carefully lower the shell of the toaster back down to its base.
- Lift and lower the toasting lever a few times to ensure that the support bracket is firmly in place.

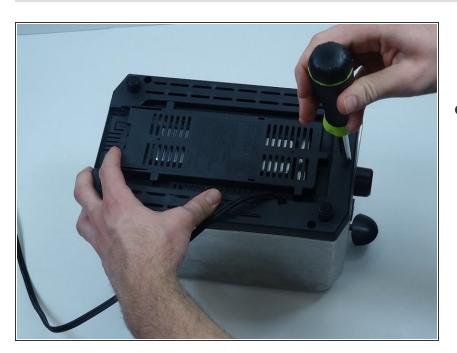
Step 8

Screw on the bottom of the toaster using all five 5mm Phillips #1 screws.
