Garmin Forerunner 735XT Teardown

Teardown of the glued forerunner series

The unit featured here developed a fault, in under two years of active use.

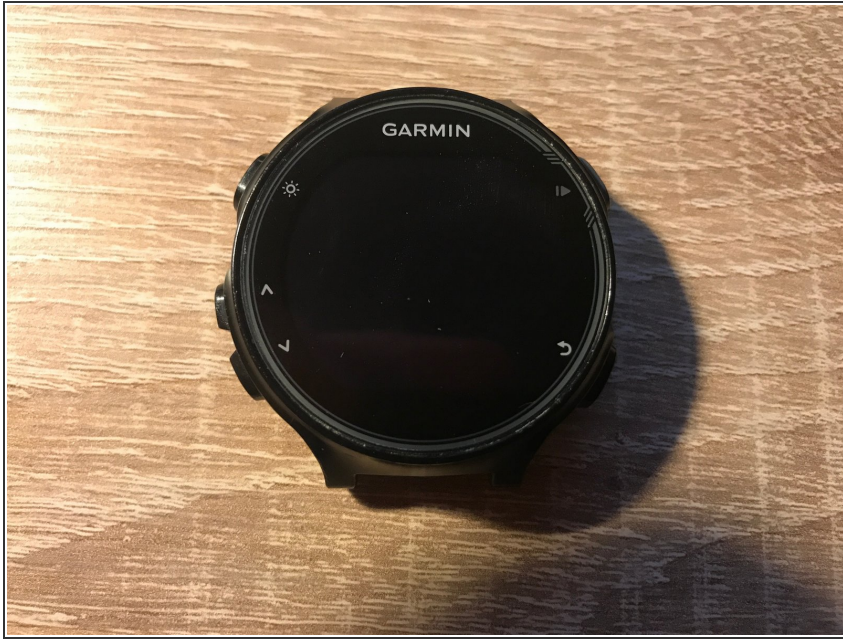
Step 1 — Garmin Forerunner 735XT Teardown

- The strapless 735xt, the straps are secured by two T6 screws on each side.

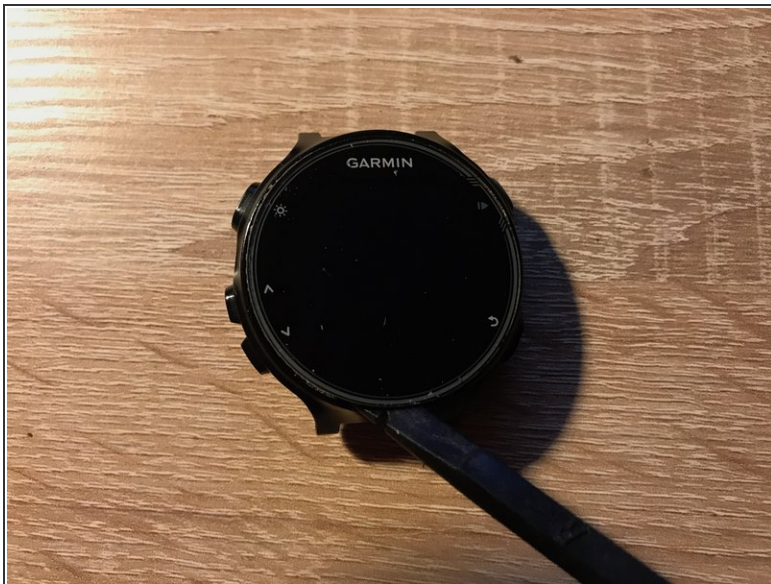
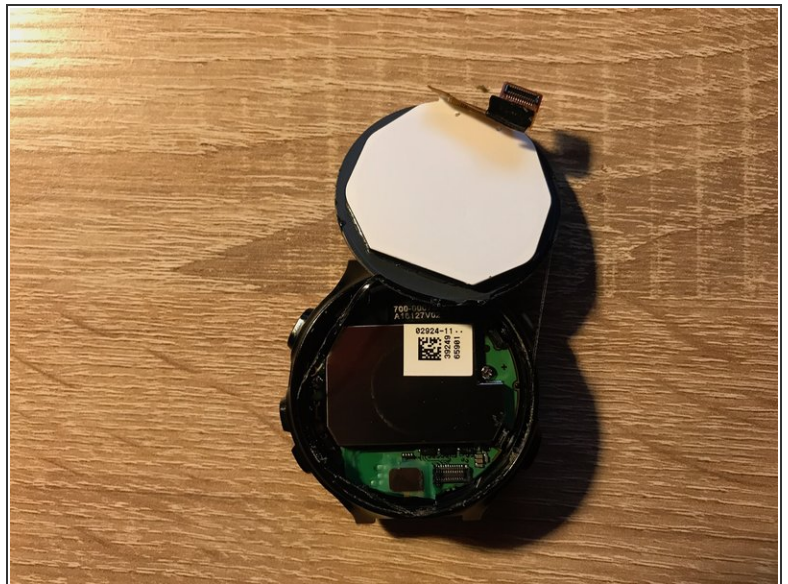
Step 2 — Prise off the front

- The front is glued
- Use an iFixit Spudger to prise around the glue. It's not necessary to use a heat gun here.

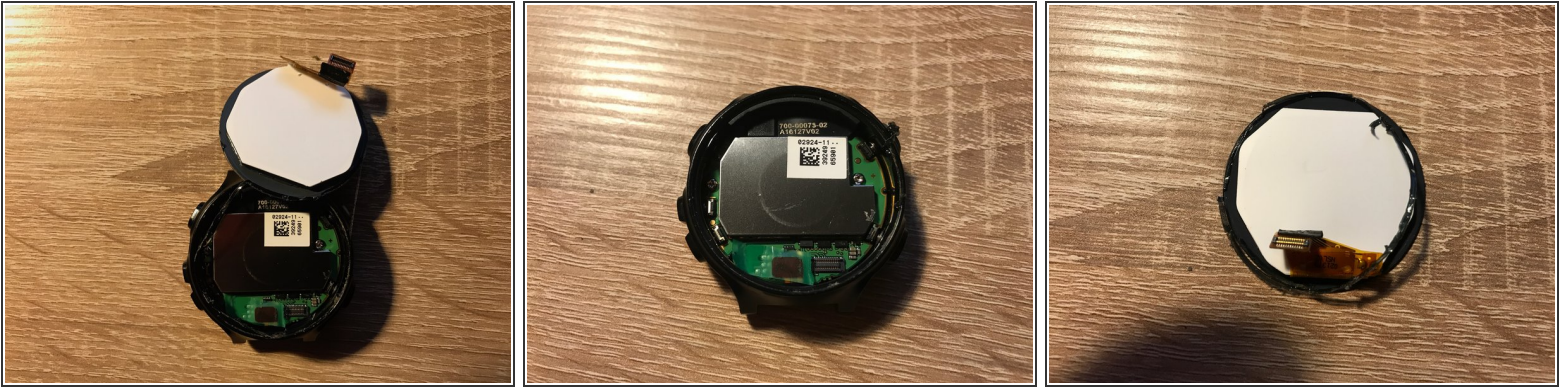
Step 3 — Carefully remove the screen

- Once the screen moves, carefully remove the ribbon connector and the screen.

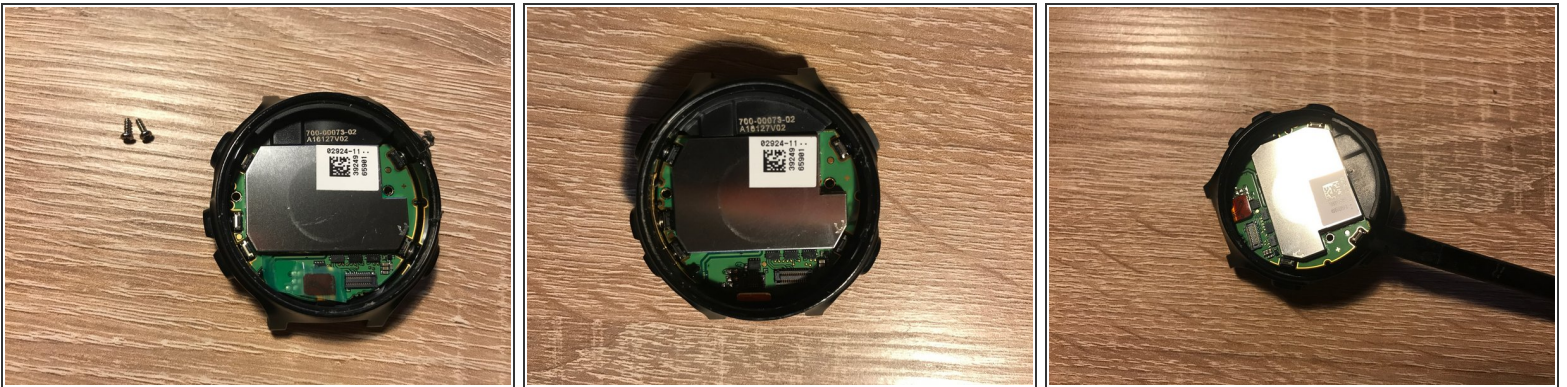
Step 4 — Remove the main board

- Two T6 screws hold the mainboard to the body.
- The main board will move from where the Spudger is inserted.
- Remove the green protective tape and disconnect the second ribbon cable before proceeding.

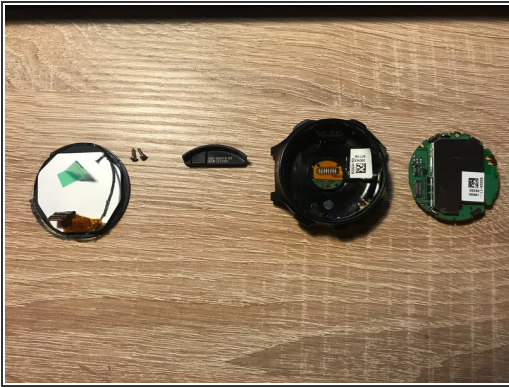
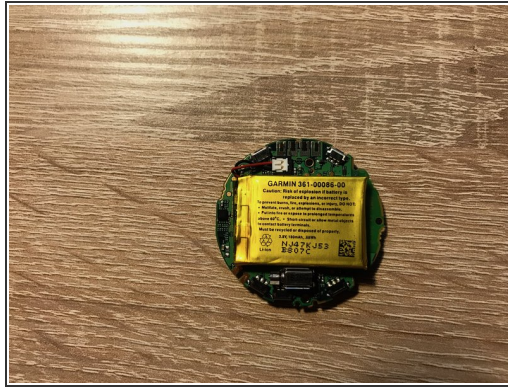
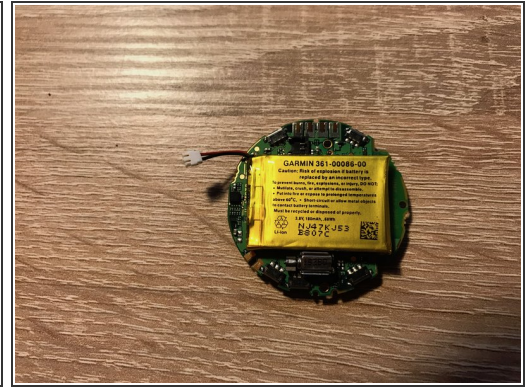
Step 5 — Disassembled

- The unit will now be disassembled
- Unplug the battery by lifting up the connector from the bottom.
- Further disassembly and analysis to follow...

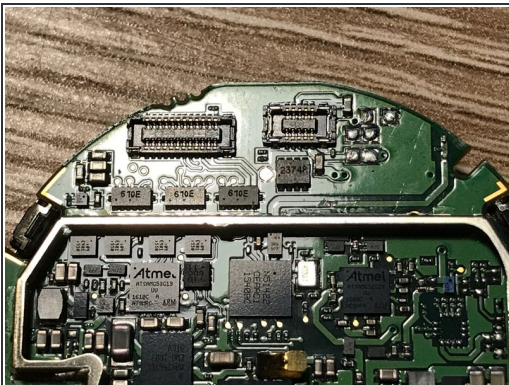
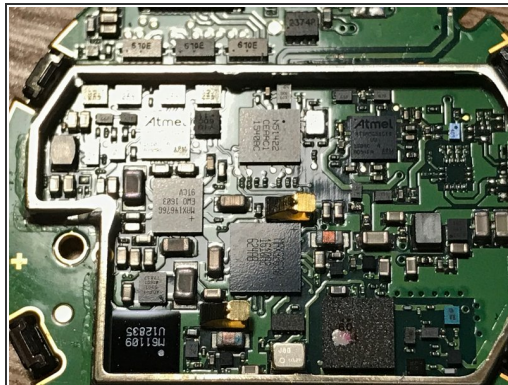
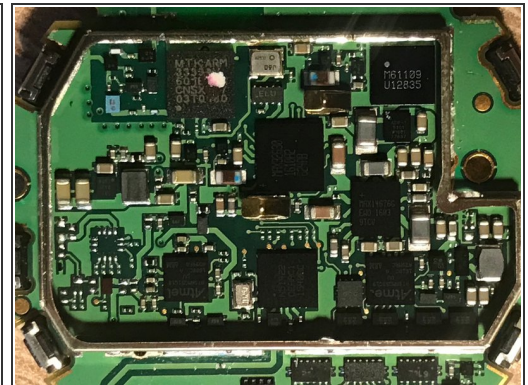
Step 6 — Closeup

- GNSS receiver looks like MediaTek MT3333 with external amplifier+filter+chip antenna. And ARM7 CPU.
- The watch has at least 3 Cortex-M4 microcontrollers, not counting Ant+ or GNSS chips! Microchip ATSAMG51, ATSAMG53 and MAX32360
- nRF51422 contains ANT+ and Bluetooth LE functionality. And Cortex-M0 CPU to run these.
