Logitech MBJ58 Mouse Top Cover Replacement

How to replace the Logitech MBJ58 Mouse top cover.

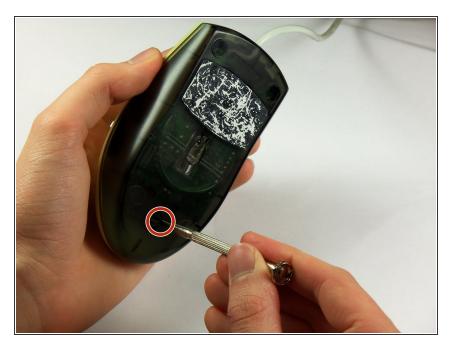
Step 1 — Top cover

- Hold the mouse so that the bottom is facing up.
- Remove the single Phillips #1 screw from the bottom half of the mouse.

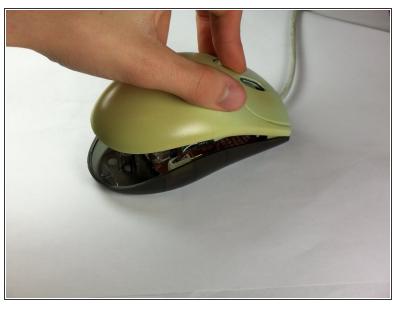
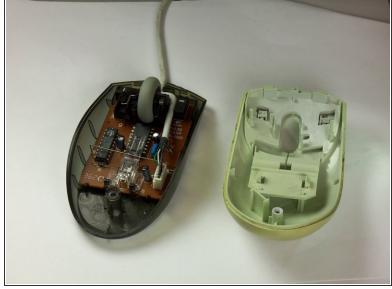
Step 2

- Place the mouse so that the bottom is resting against a hard surface.
- Lift the top cover of the mouse gently, and remove it.
