Morphy Richards Power Steam Elite Iron.

Damaged flex cable easy fix.

Intermittent vibration from steam generator as you iron. Heating and steam issues.

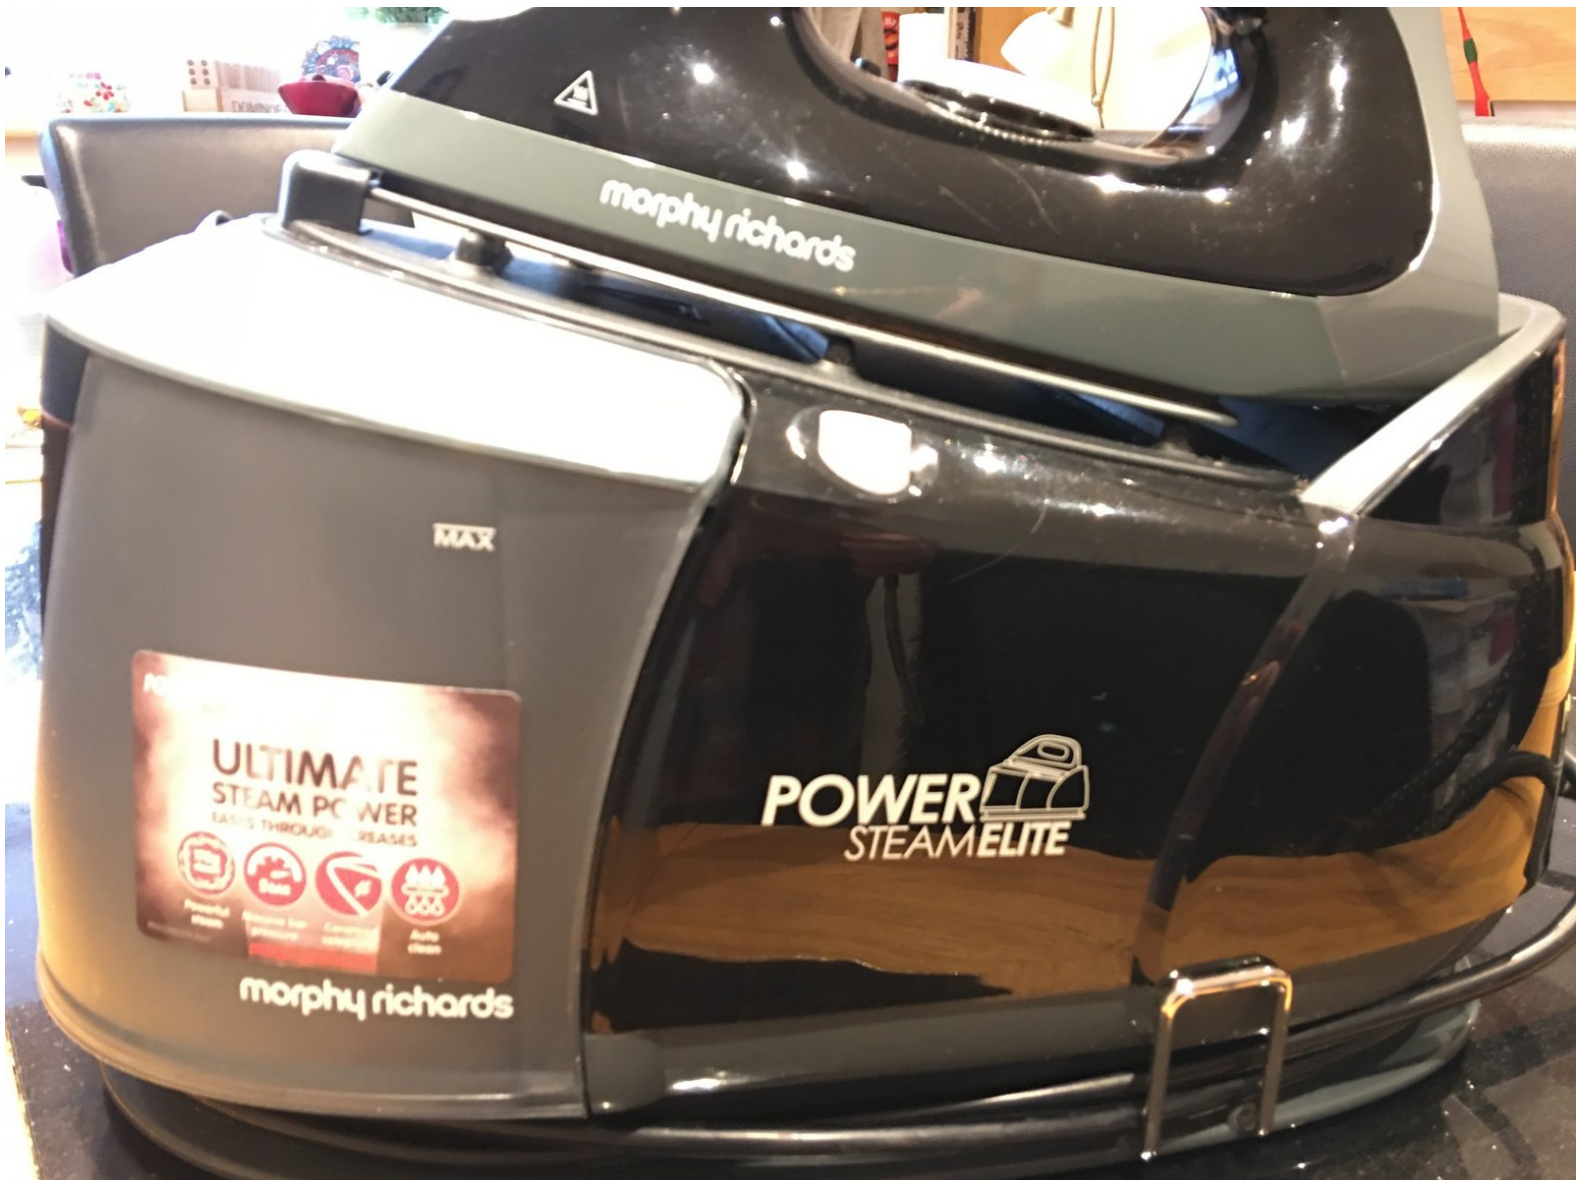
Here we have a used Steam Generator Iron been in use for several years with no problems at all. Like any electrical product that moves a lot the mains cable suffers constant to and fro movement, in this case, during ironing. This action work hardens the multi core individual wires in the cable. You will notice the mains plug and the steam generator mainly sits still in use, only the heated iron moves during use causing the fractures in the leads and failure.

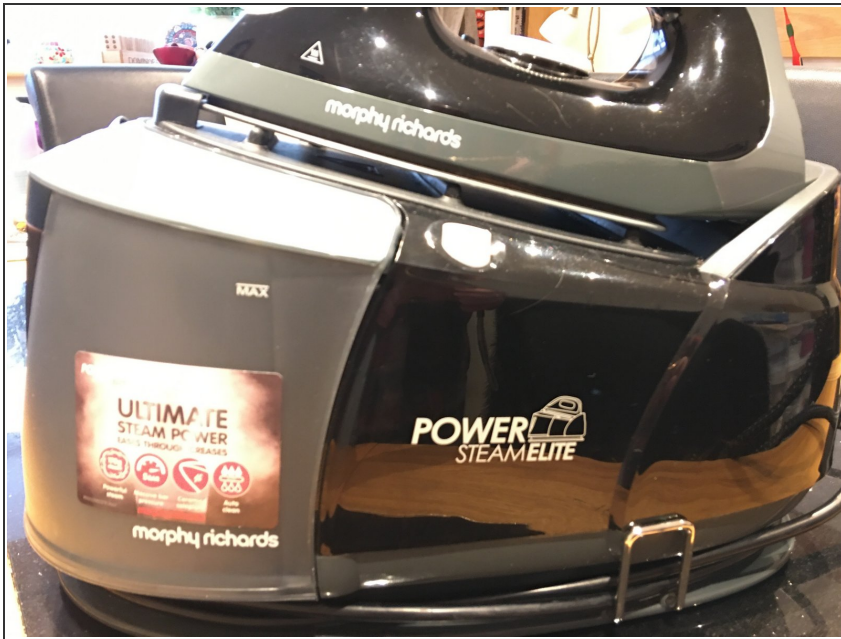
Step 1 — Damaged flex cable

- Check ALL your irons electrical earth protection to the Earth pin on the mains plug.
- Remove mains plug from socket at all times.

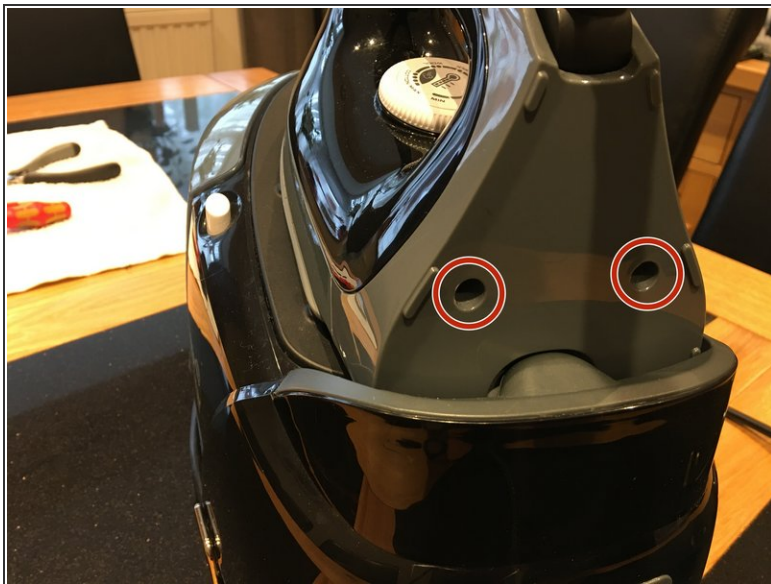
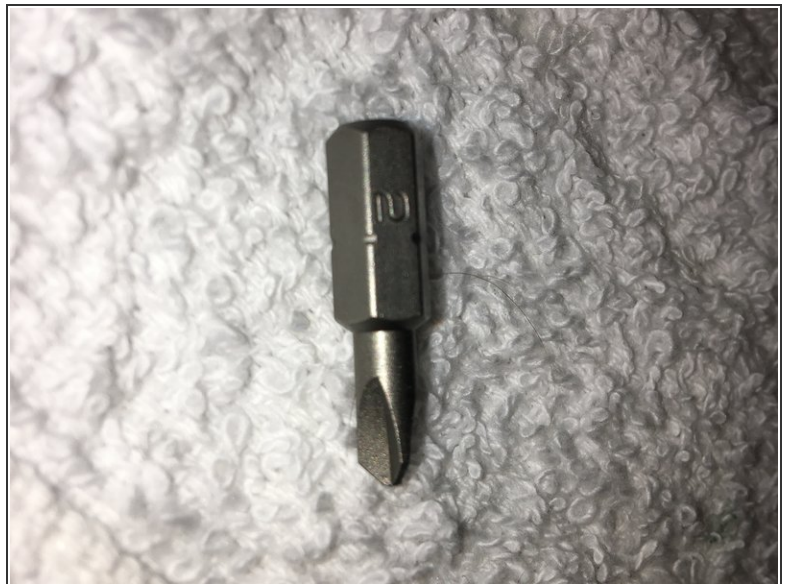
Step 2

- Take photographs as you work for reference later.
- Remove two tri screws to remove inspection cover.

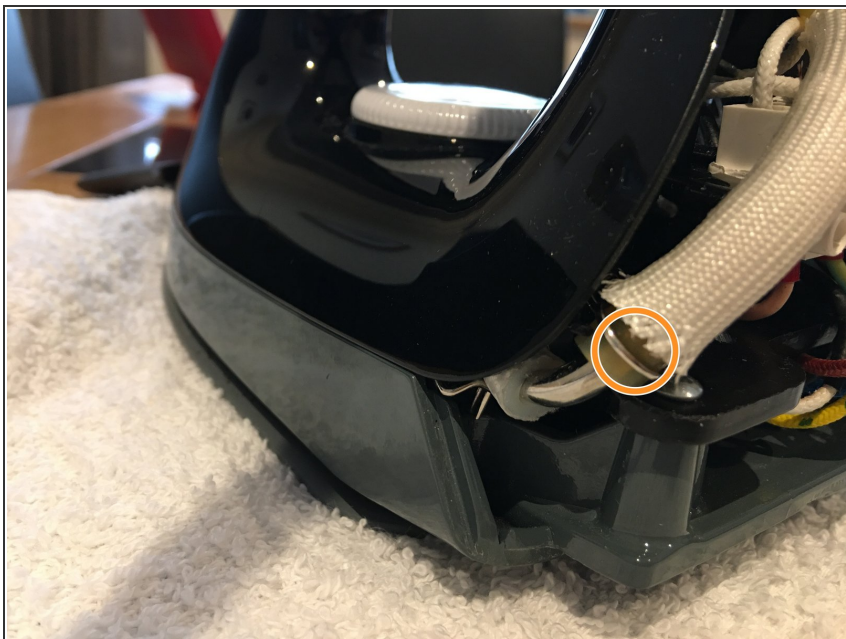
Step 4

- With small pliers locate water tube and squeeze locking ring around small chromed tube (orange), near sole plate and carefully slide away and remove silicon hose from chromed tube.

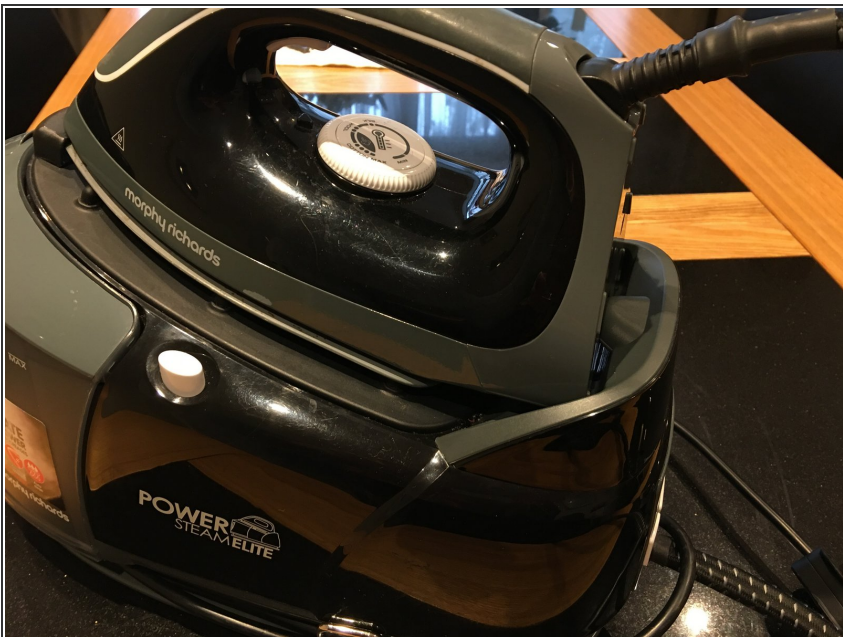
Step 8

- Replace cover and two tri screws and test.
