MSI GP62MVR 6RF Leopard Pro Hard Drive Replacement

This guide will show you how to replace the hard drive in the MSI GP62MVR 6RF Leopard Pro laptop.

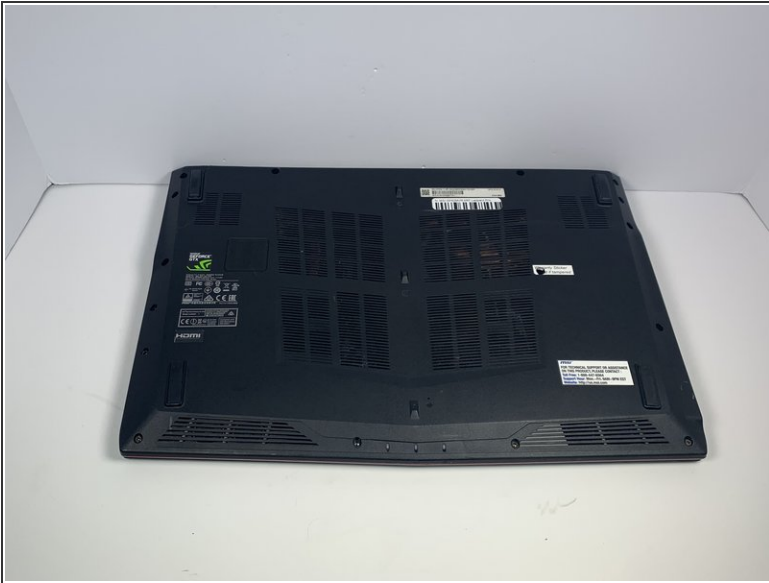
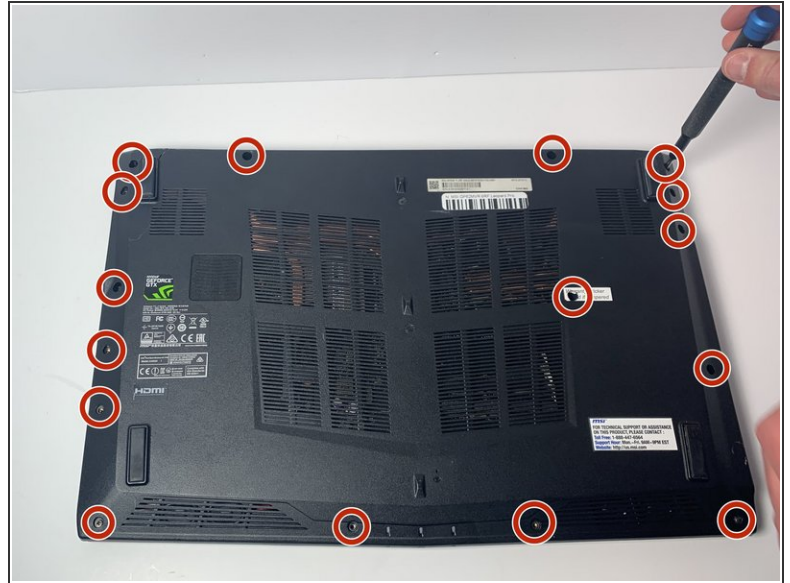
Step 1 — Bottom Cover

- Place the laptop upside down.
- Remove the sixteen 5.5 mm screws with a Phillips #0 screwdriver.

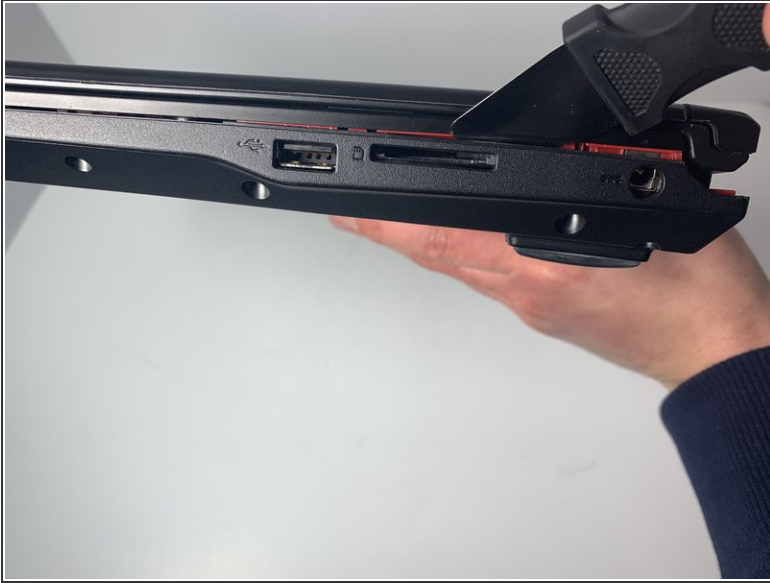
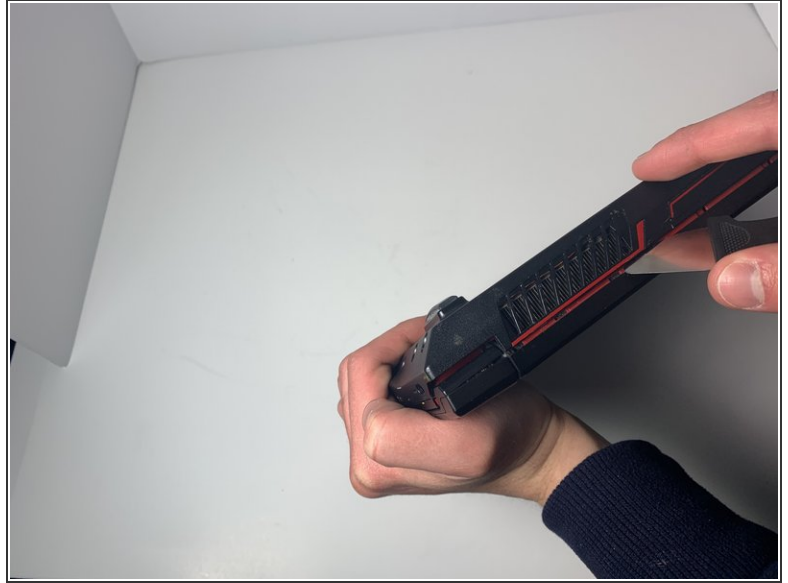
Step 2

- Use the Jimmy tool to evenly pry loose the bottom cover.
- Ensure that all sides are detached from the plastic hinging before attempting to remove the bottom cover.

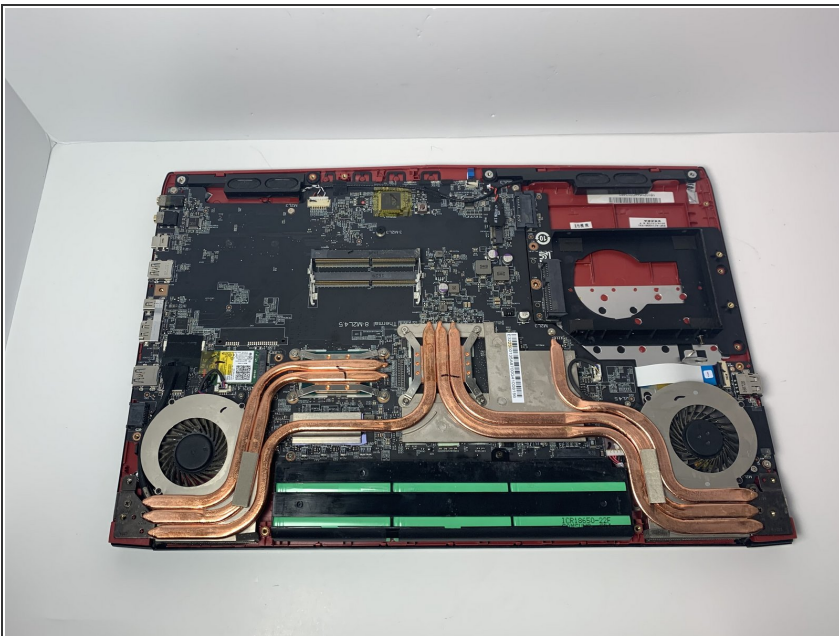
Step 3

- Remove the back cover.

Touching circuitry could damage components or result in personal shock; it is recommended that you now wear latex gloves to prevent both issues.
