Hytera TC-580 Speaker Replacement

If you are having issues hearing other people...

INTRODUCTION

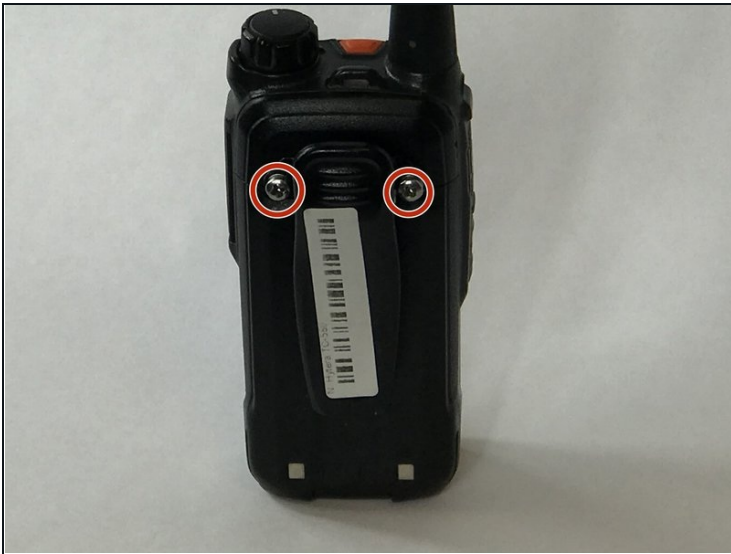
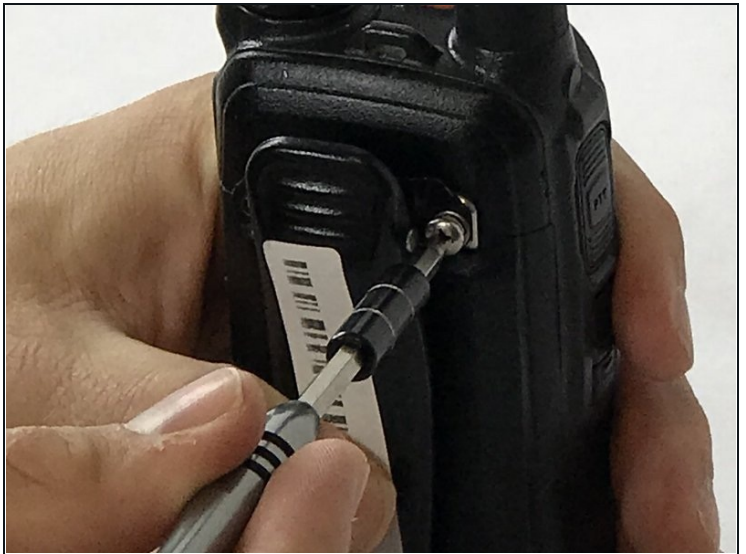
Step 1 — Battery

- Remove the two 10mm Phillips #0 from the belt clip.

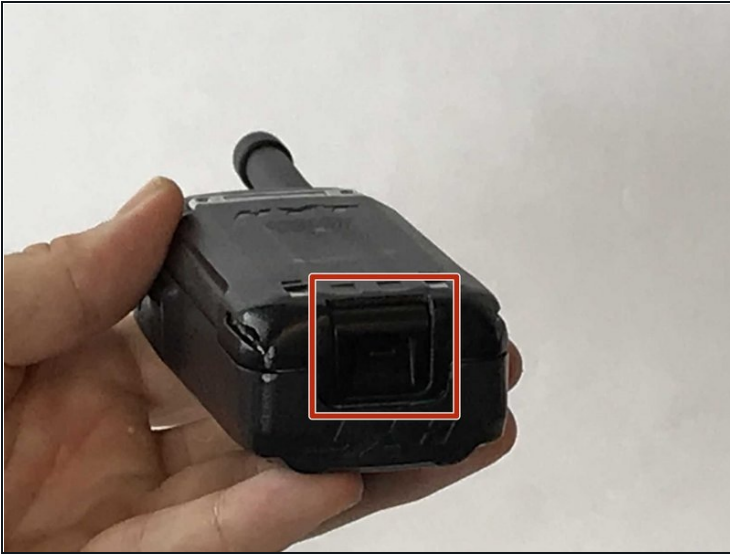
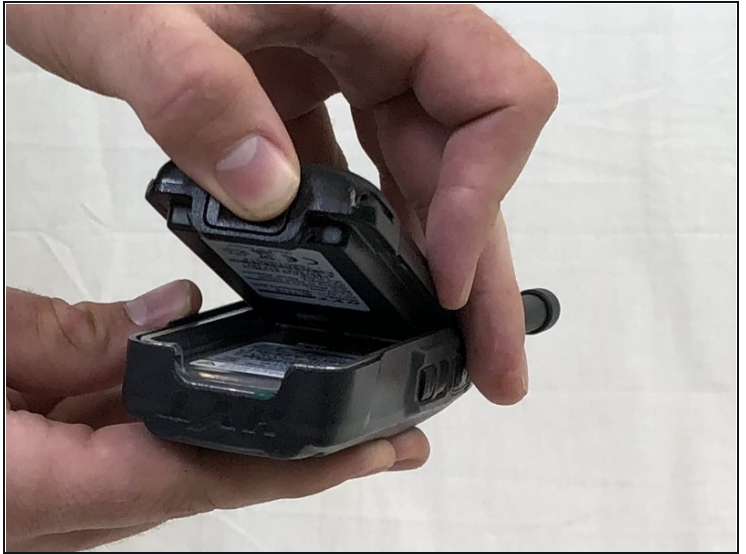
Step 2

- Push in the release button and pull up on the battery to remove.

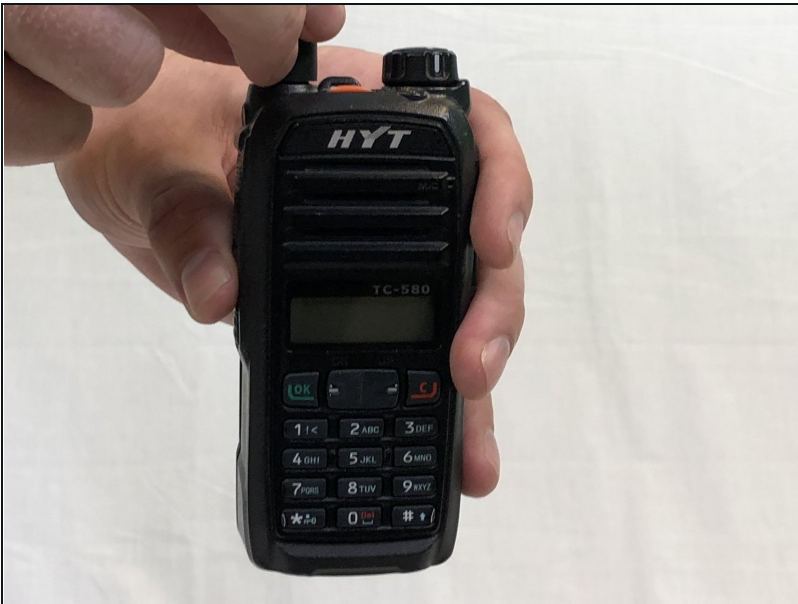
Step 3 — Antenna

- Twist antenna counter-clockwise and set damaged antenna aside.

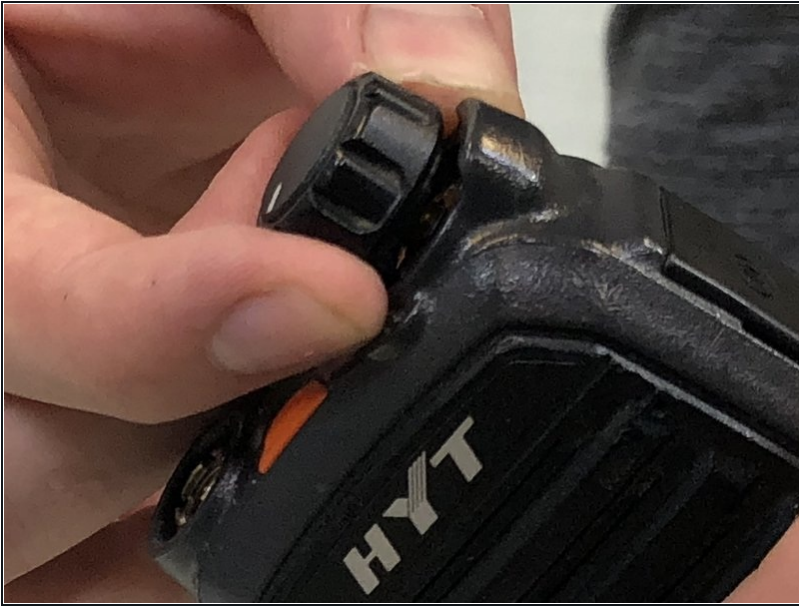
Step 4 — Keypad

- Remove the volume knob by firmly lifting up on both sides of it.

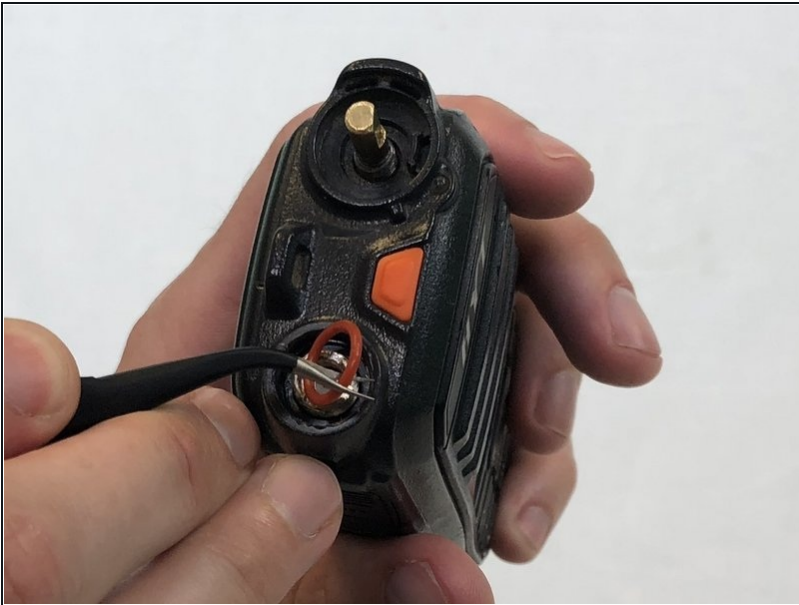
Step 5

- Remove the orange o-ring around volume knob using [tweezers](#).

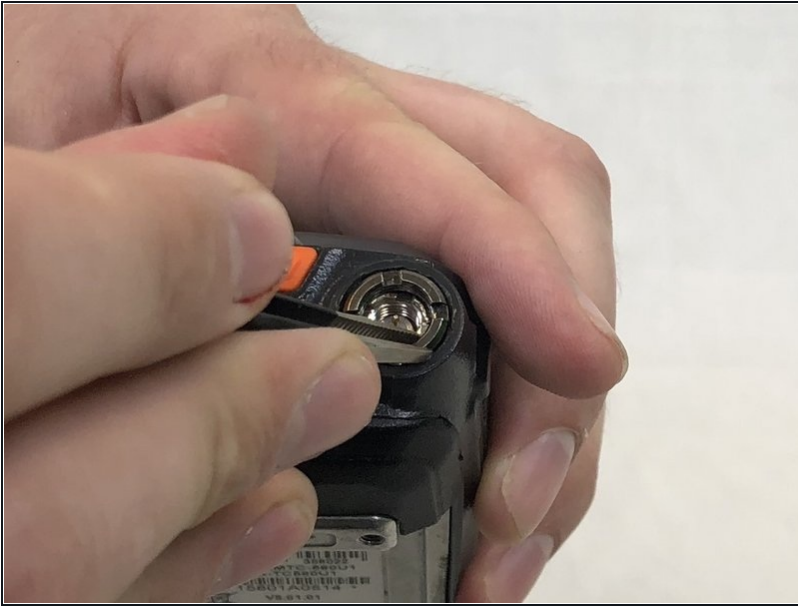
Step 6

- Remove grey nut from base of volume knob by turning it counterclockwise with a set of tweezers.

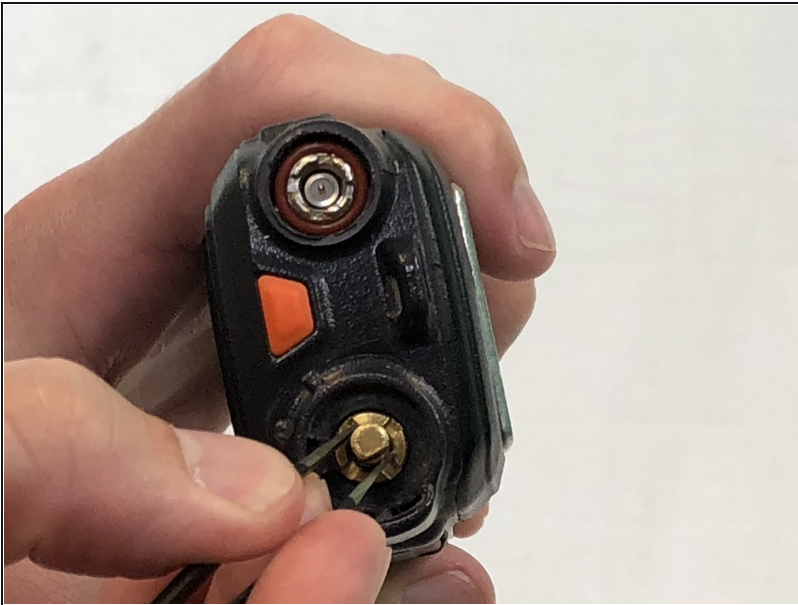
Step 7

- Remove the brass washer from the base of the antenna slot by turning it counterclockwise with a set of tweezers.

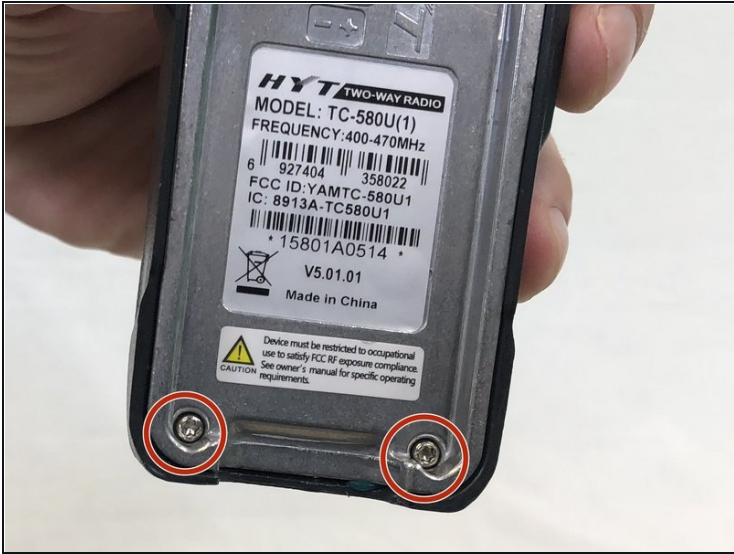
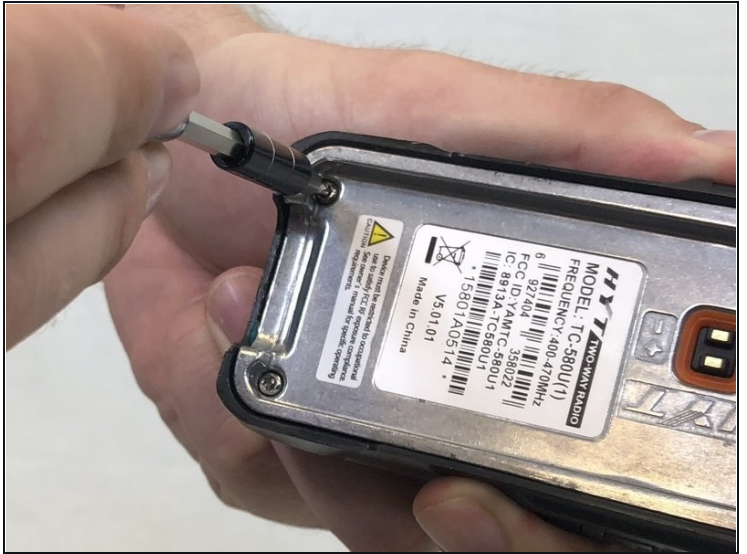
Step 8

- Remove the two 15mm T8 Torx screws from the base of the battery cavity.

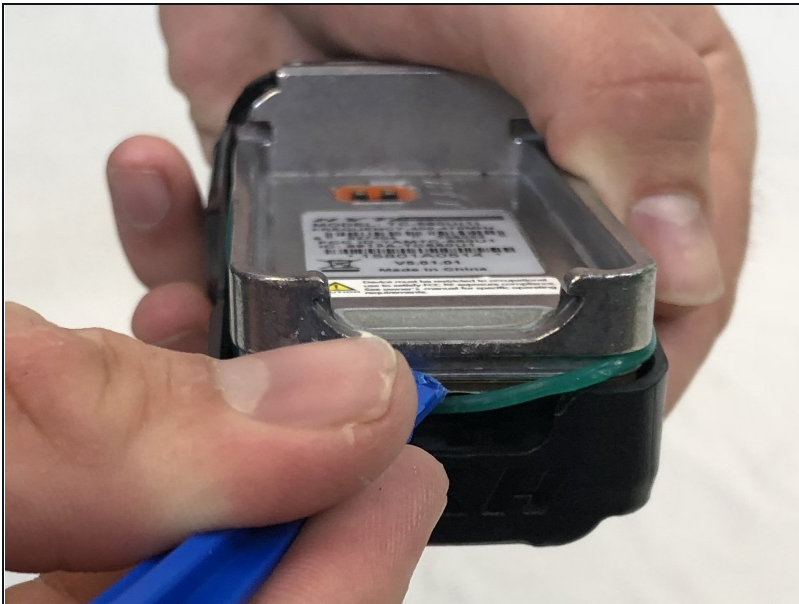
Step 9

- Using a plastic opening tool, pry in between the plastic case and metal circuit board to remove the board.

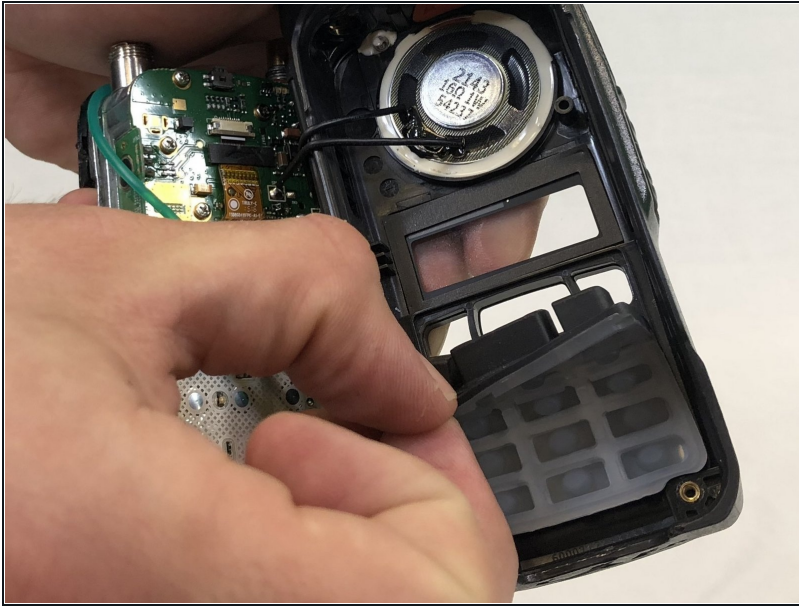
Step 10

- Peel off the keypad by hand.

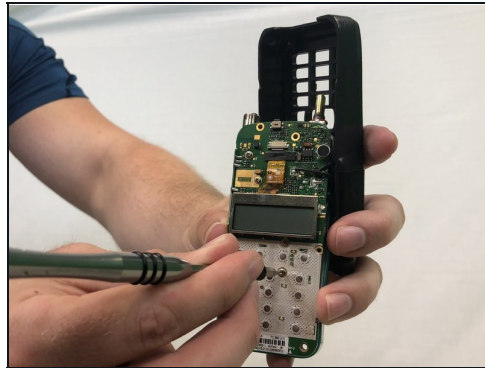
Step 11 — Speaker

- Remove eleven 4mm Phillips #00 screws.
