Ford Taurus Air Re-Circulation Door Motor Replacement

This guide will show you how to replace the Air Re-Circulation Door Motor in your 2008 Ford Taurus.

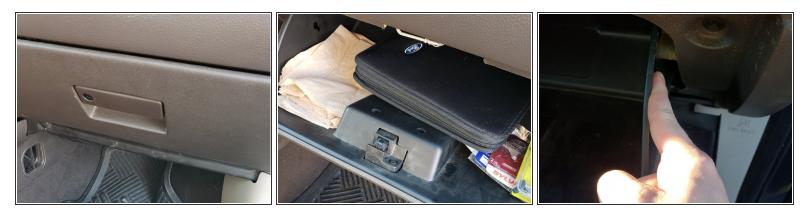
Step 1 — Time to drop the glovebox (Not literally)

- Tired of the clicking/grinding when using the air re-circulation feature in your Taurus? Follow this guide, and there will be no more of it.
- Make sure to empty out your glovebox, so when you drop it down, all of your stuff doesn't fall out.
- Once your glovebox is empty, gently press in on both sides to release the latch, and the glovebox will fold down towards the floor.

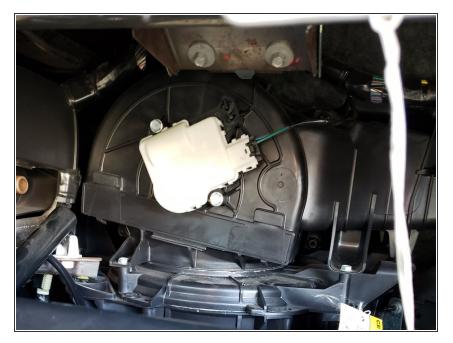
Step 2

- Looking ahead, you'll see the white motor with two 11mm mounting screws.
- First pull the wire connector from the harness by pressing the harness clip, and gently pull the wire out.
 Now it is disconnected, and you can let it dangle. (Don't worry it won't run off)

- Now you can use an 11mm socket attached to a ratchet to quickly unscrew the two screws. Once the screws are free, gently pull the motor out.
- Replace with Motorcraft YH-1779 Motor Assy.

- When installing the new motor, ensure the teeth on the spindle match up to the direction they are in on the connector. Don't worry about lining it up perfectly with the screw holes when installing it, as you can make the adjustment when it pops in.

- Lastly, tighten down the two 11mm screws, but be careful not to crack the plastic by tightening them too tightly. Now connect the electric wire into the harness, and you can gently push both sides of the glovebox back in, and lift it back into place. Good job, no more grinding!
