Ridgid GEN5X R8642 Battery Port Replacement

How to replace a Ridgid GEN5X R8642 battery port.

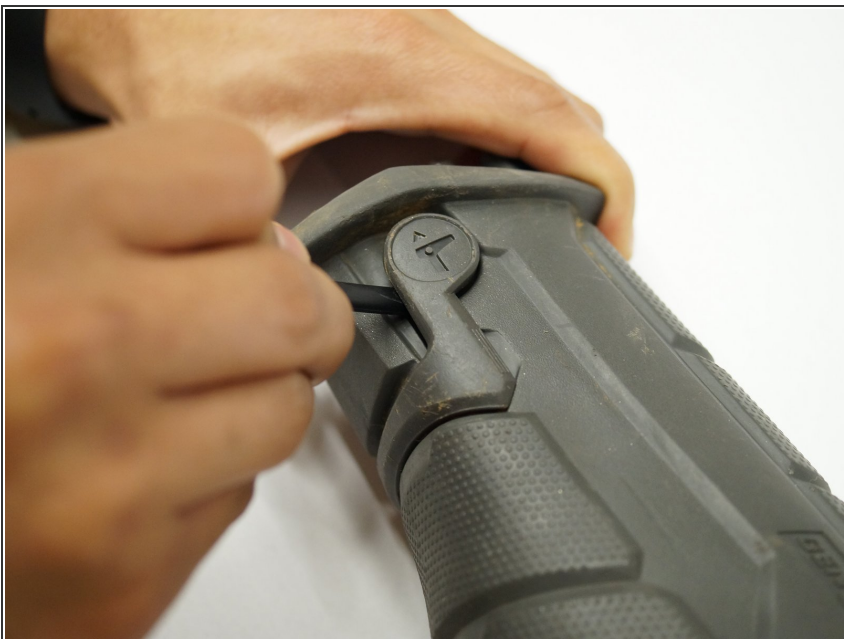
Step 1 — Battery Port

- Remove the plastic tab holding the handle cover in place by prying upward with the spudger until the tab pops off.

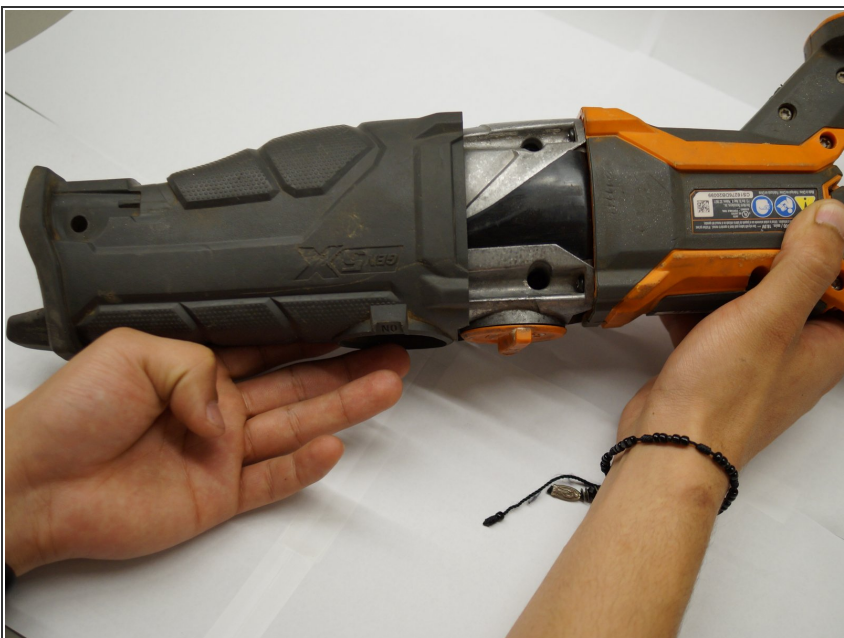
Step 2

- Remove the handle cover by pulling it towards the front of the saw.
- ⓘ The grip can sometimes become stuck and may require a decent amount of force to remove.

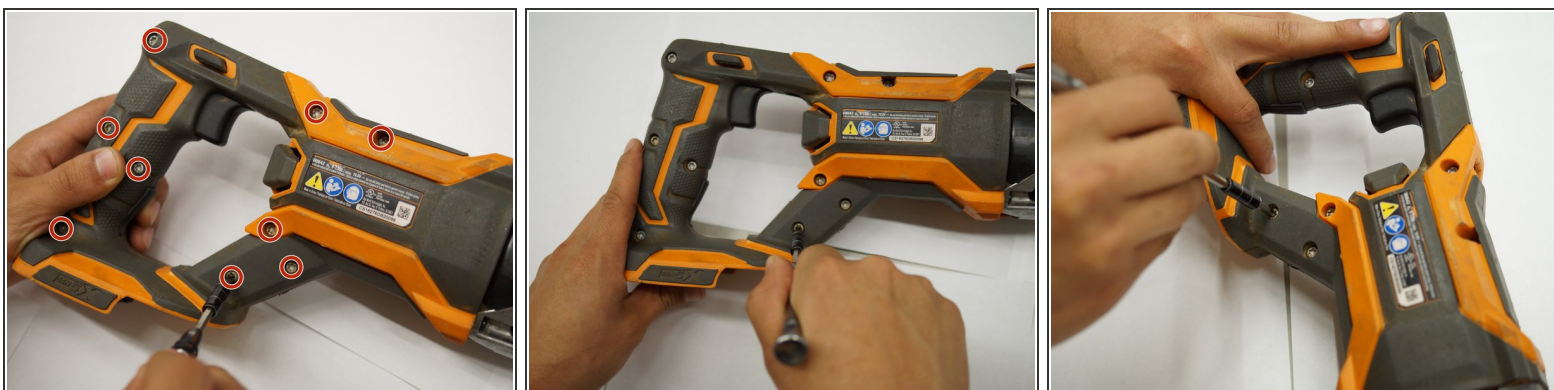
Step 3

- Use a T20 Torx screwdriver to remove the nine M4 X 16mm screws from the plastic housing.

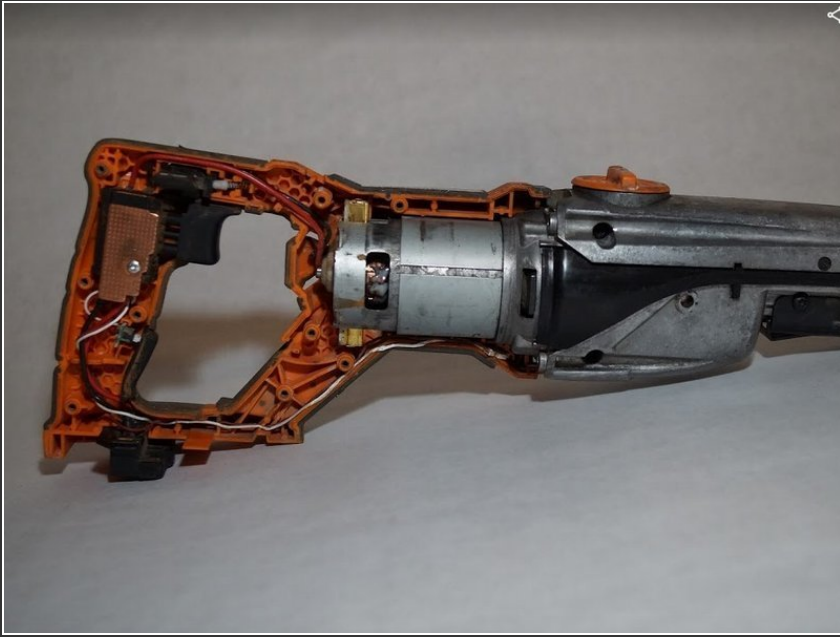
Step 5

- Remove one half of the plastic housing using a spudger so that the internal system is exposed.
