# MSI GT70 MS-1763 Hard Drive Replacement

Written By: Brad Dunlap

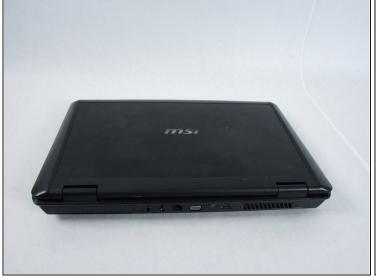
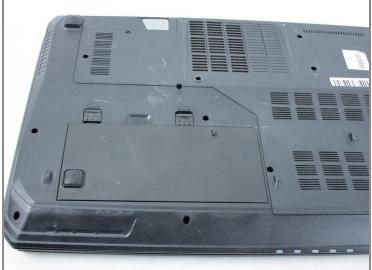
#### Step 1 — Battery

Power off the laptop and turn it over.

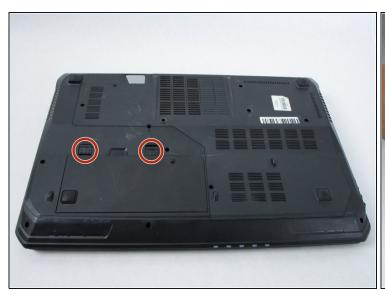
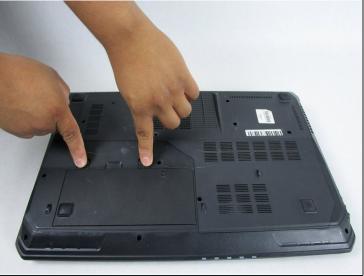
### Step 2

Release the safety latches that hold the battery in place. The left latch will stay moved up, while the right side is spring activated and will have to be held.

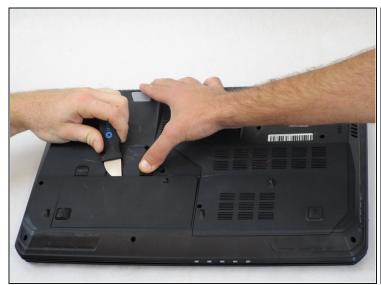
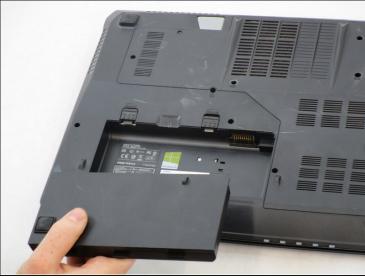
### Step 3

• While holding up the left latch, use a Jimmy and slide the old battery out of its compartment.

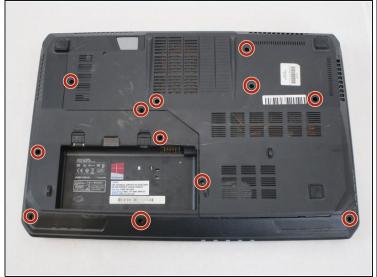
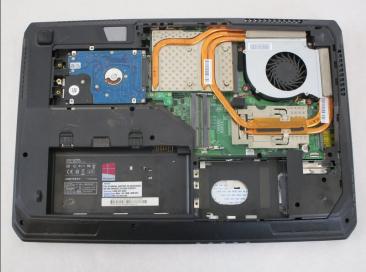
### Step 4 — Hard Drive

- Remove all twelve 4 mm Phillips #0 screws from the back of the laptop.
- Remove the back cover.

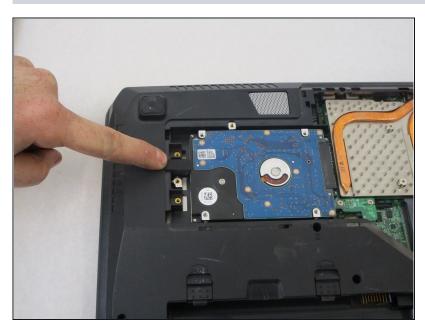
### Step 5

• Remove the rubber spacer holding the hard drive secure.

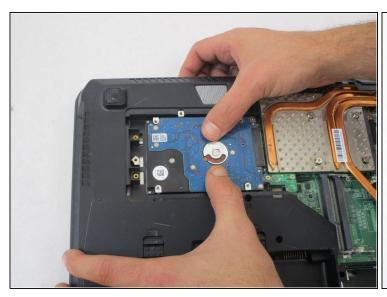
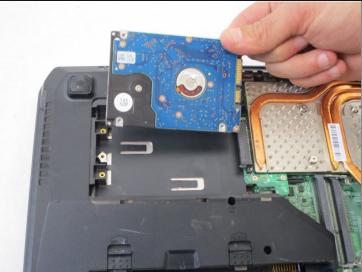
## Step 6

Slide the hard drive to the left, removing it from its bay.

To reassemble your device, follow these instructions in reverse order.
