Razer Blade RZ09-0130 2015 Fan Replacement

Written By: Tyler Clayton

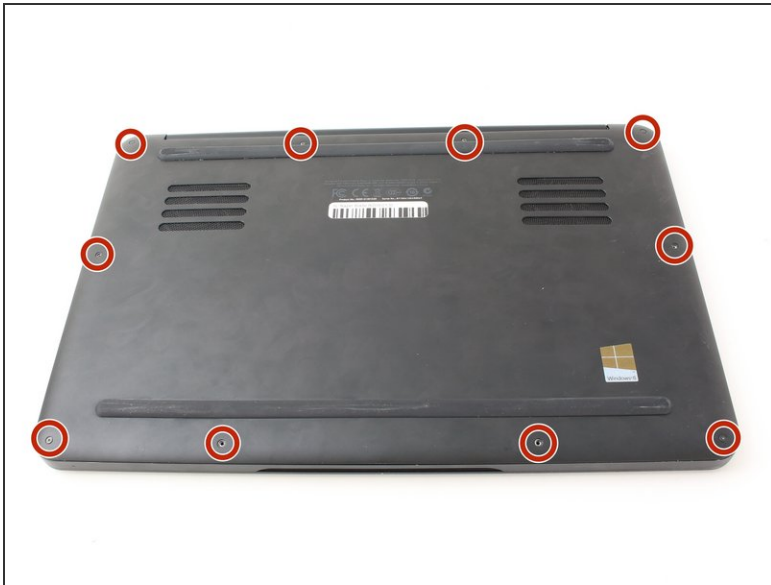
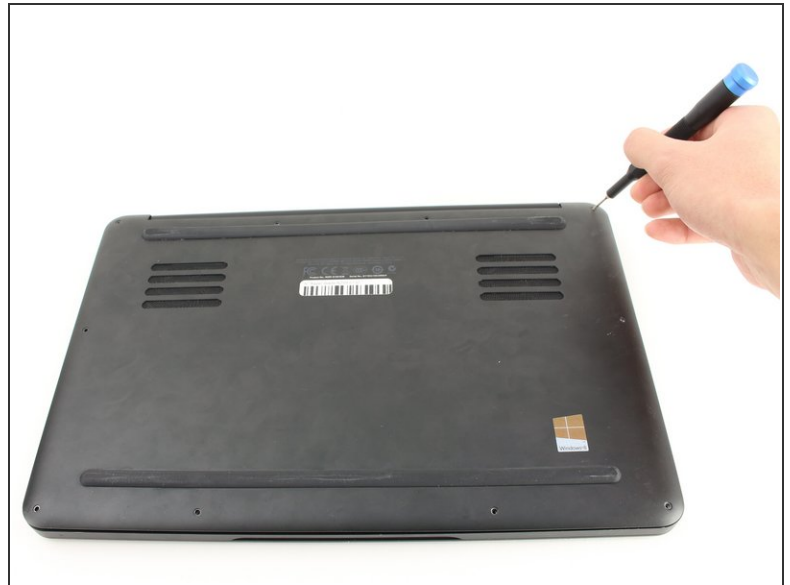
Step 1 — Back Panel

⚠ Be sure to power off the device before beginning.

- Use a Torx T5 screwdriver to remove the ten 3 mm screws along the edge of the back panel.

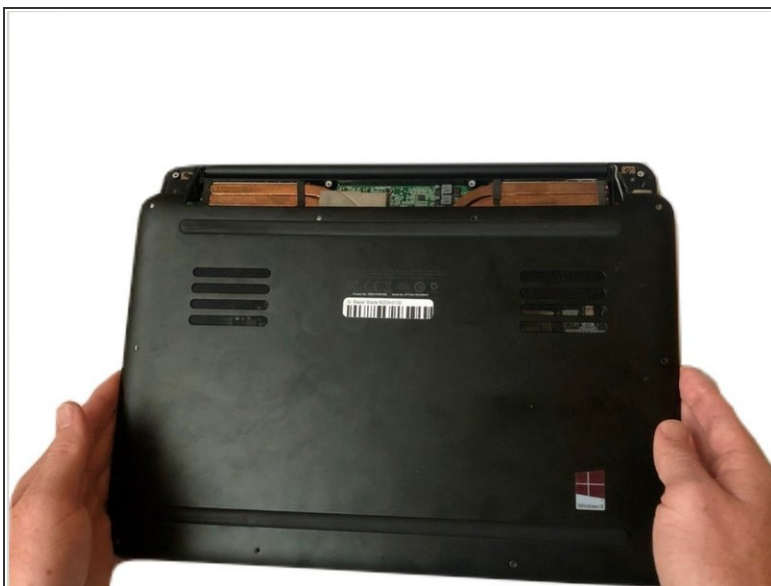
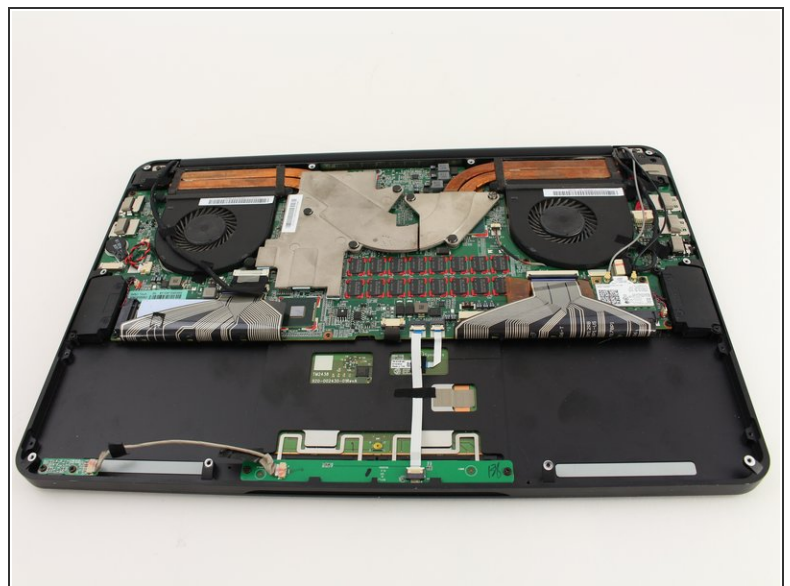
Step 2

- Remove the back panel from the laptop by sliding it away from the hinge.
- ⓘ This device is missing the battery. Make sure to detach the battery connector before proceeding with laptop repairs.

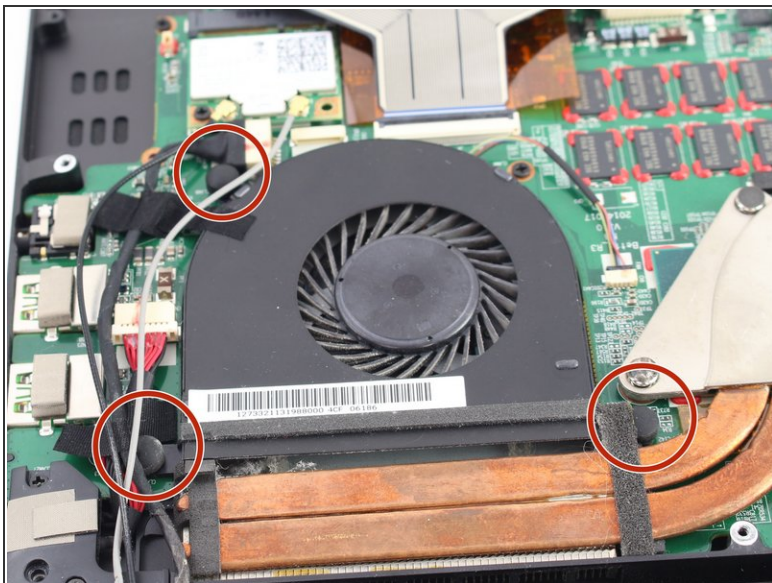
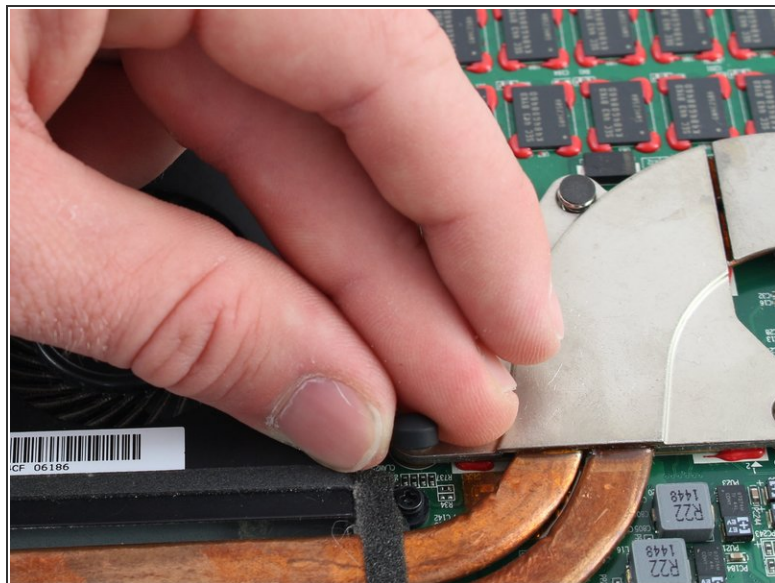
Step 3 — Fan

- Remove the three screw caps by pulling them upward with your fingers.

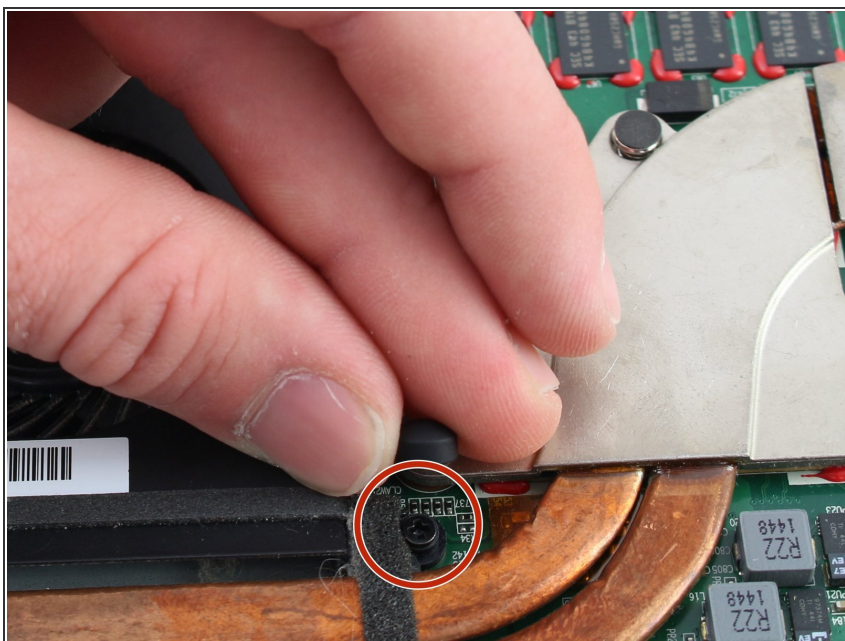
Step 4

- Remove the three 3mm Phillips #0 screws.

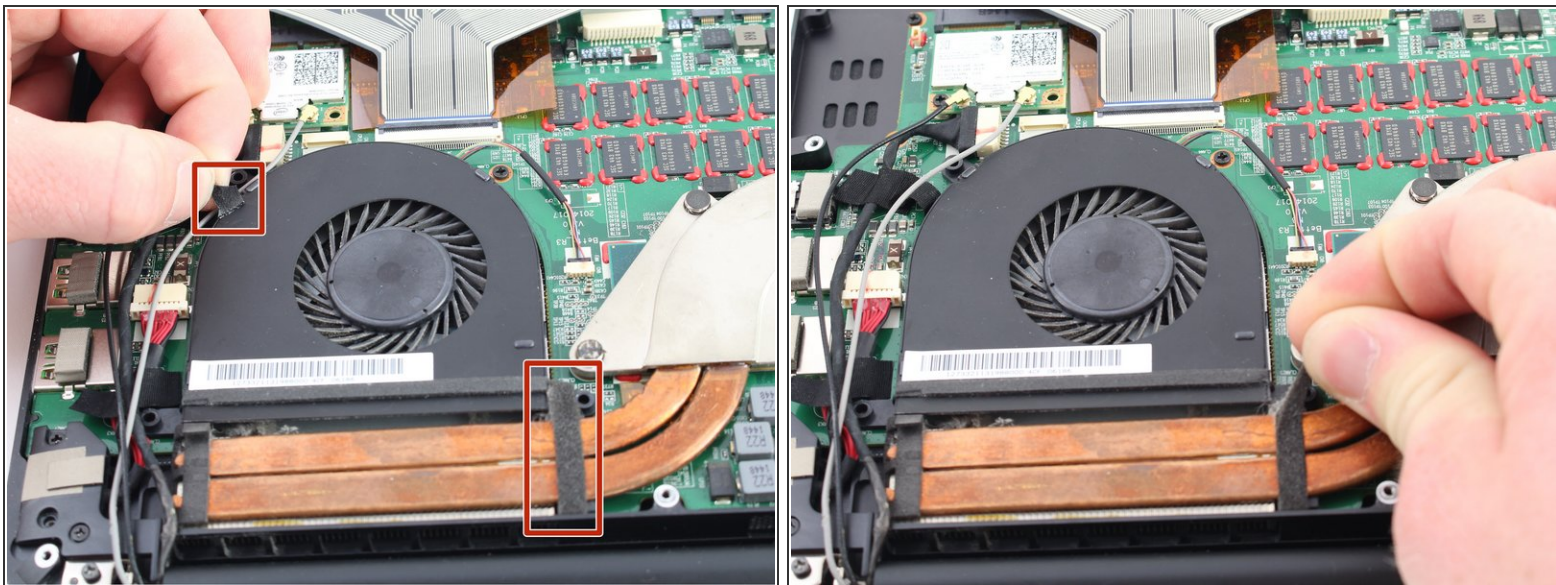
Step 5

- Peel back the two adhesive strips from the fan until they are removed.

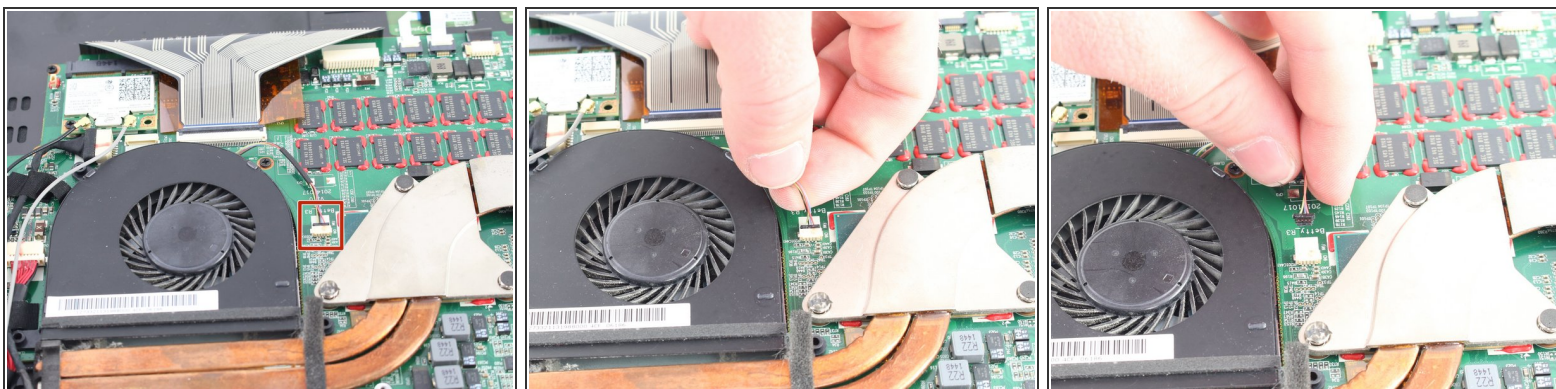
Step 6

- Remove the connector by pulling it away from the motherboard with your fingers.

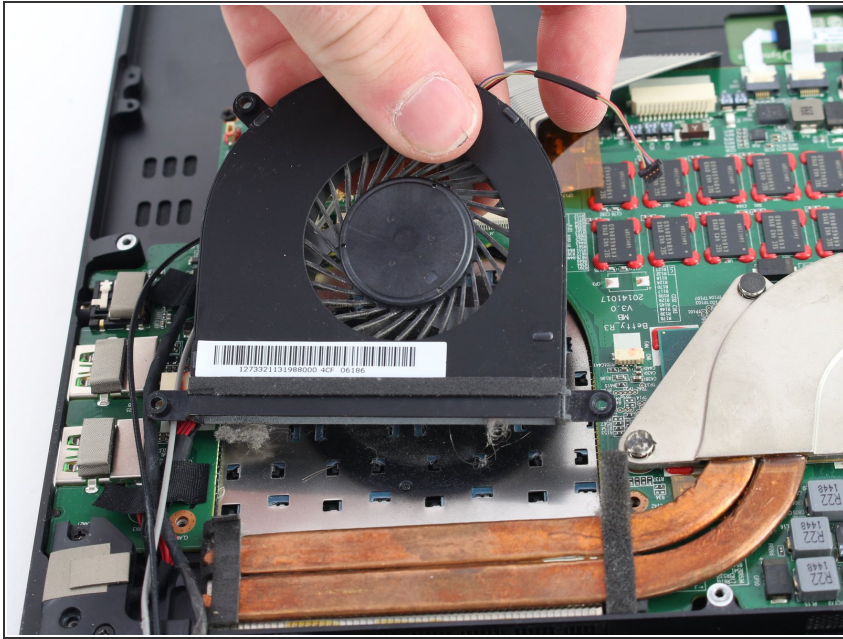
Step 7

- Holding the rounded edge of the fan, slowly lift upwards until it is removed.

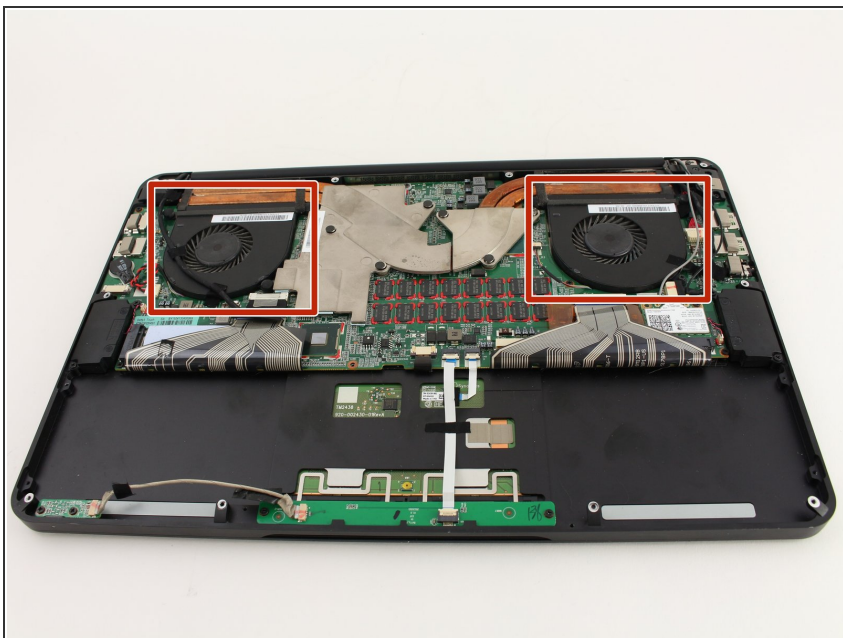
Step 8

- Repeat the preceding steps to remove the second fan.
