Oster 6329 Bread Grabber Spring Replacement

Written By: Isaac Williams

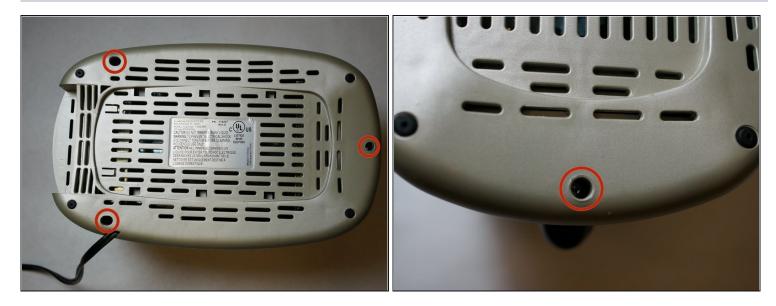
Step 1 — Outer Shell Removal

• Using the Phillips-head #2 screwdriver, unscrew the three 1cm Phillips-head screws on the plastic base of the toaster to separate the outer metal shell from the plastic base.

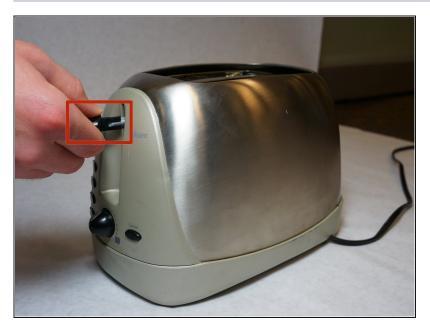
Step 2

Push the plastic push-down handle down and pull the plastic handle straight from metal arm.

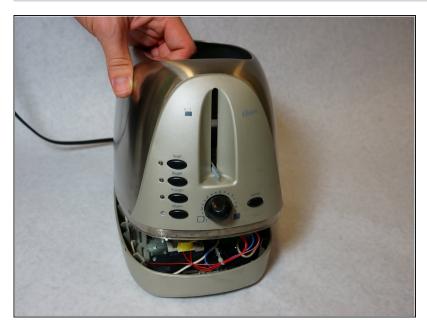
Step 3

- Loosen the outer metal shell from the plastic base by holding the plastic base while pulling up on the metal shell.
- (i) Only lift the outer shell a little so as not to disconnect the cables that connect the circuit board.

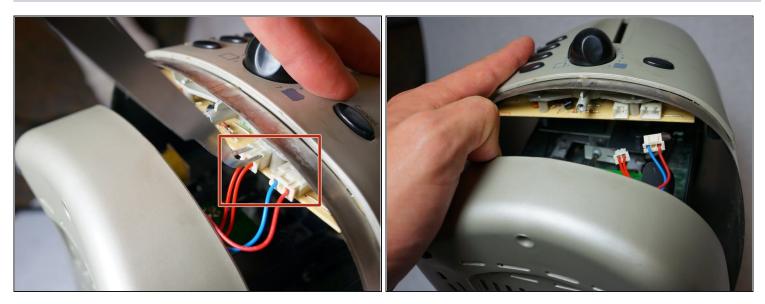
Step 4

• Disconnect the cable clips from the circuit board using the <u>tweezers</u> to free the outer metal shell from the plastic base.

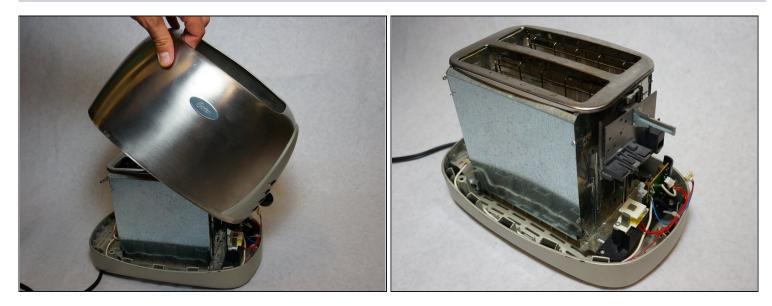
Step 5

• Lift the top outer metal shell.

△ Carefully lift the outer metal shell at an angle so as not to damage the components in the front of the toaster.

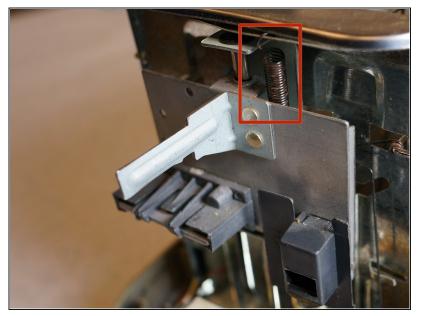
Step 6 — Bread Grabber Spring

Press down on the toaster handle to access to the grabber spring located behind the large metal plate.

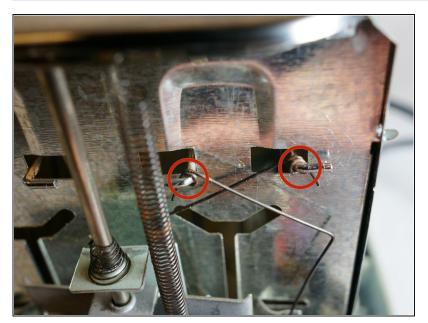
Step 7

Locate the grabber spring.

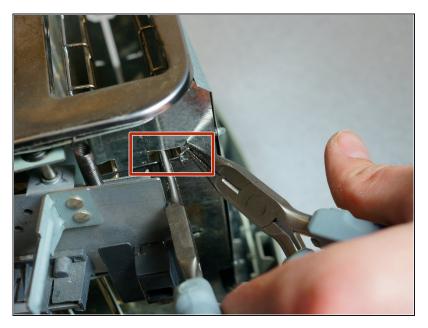
Step 8

- Use the large needle nose pliers to unwind the grabber spring from one side of the carriage to remove.
- Repeat this step for the opposite side.

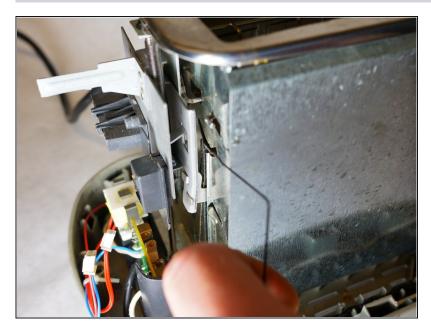
Step 9

• Remove the old spring from the toaster unit to insert new.
