Oster Blend-N-Go My Blend Blade Assembly Seal Replacement

Replace damaged blade assembly seal.

Put this guide to work in order to replace your leaking seal in the blade assembly, Note the seal is located inside of the existing blade assembly.

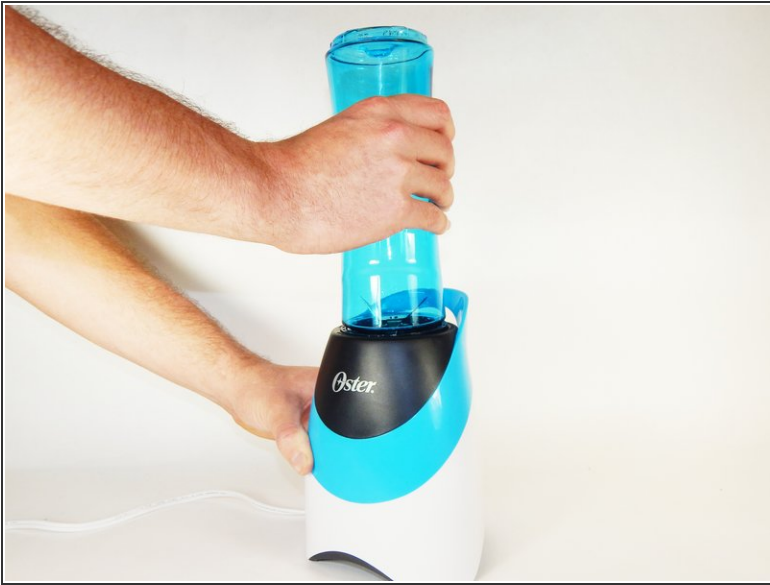
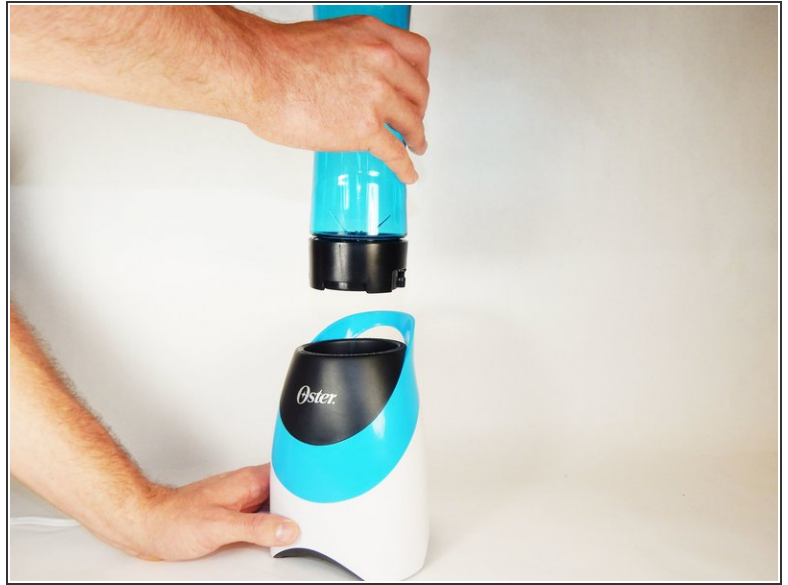
Step 1 — Blender Bottle

- Grip the blender base with one hand and blender bottle with the other hand.
- Rotate the blender bottle a quarter turn counterclockwise .
- Lift the blender bottle out of the blender base. The blade assembly should still be attached to the blender bottle.

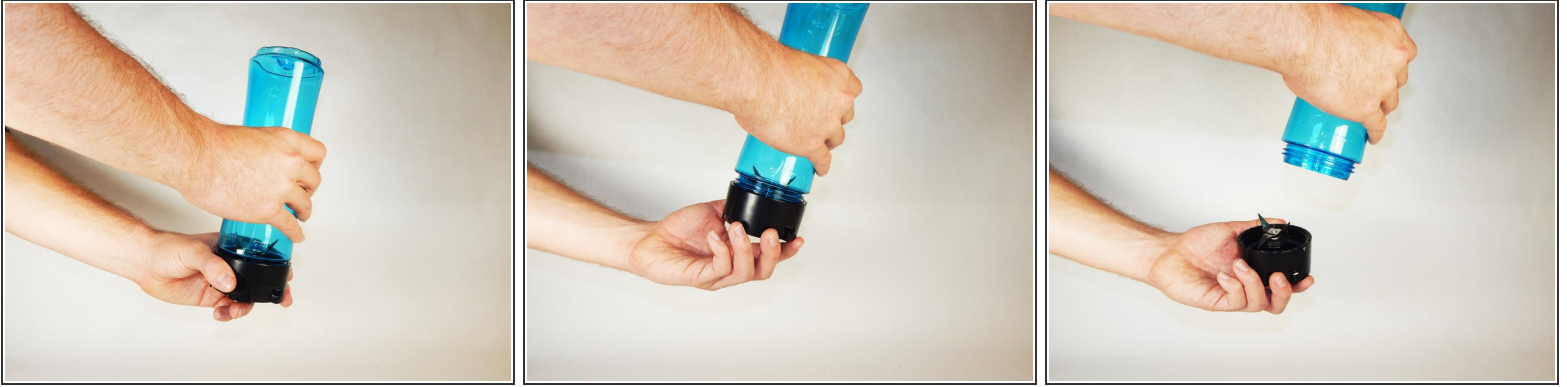
Step 2

- Grip the blade assembly with one hand and blender bottle with the other hand.
- Rotate the blade assembly counterclockwise until it is completely unscrewed from the blender bottle.
- Lift the blender bottle to separate it from the blade assembly.

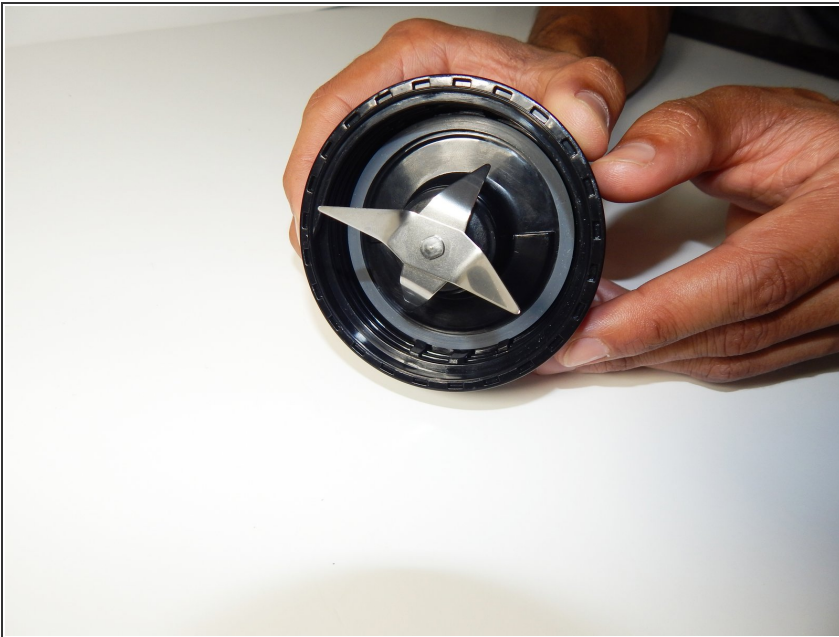
Step 3 — Blade Assembly

- After removing the blade assembly from the blender bottle, ensure your blade assembly has its seal placed in the seal bed.

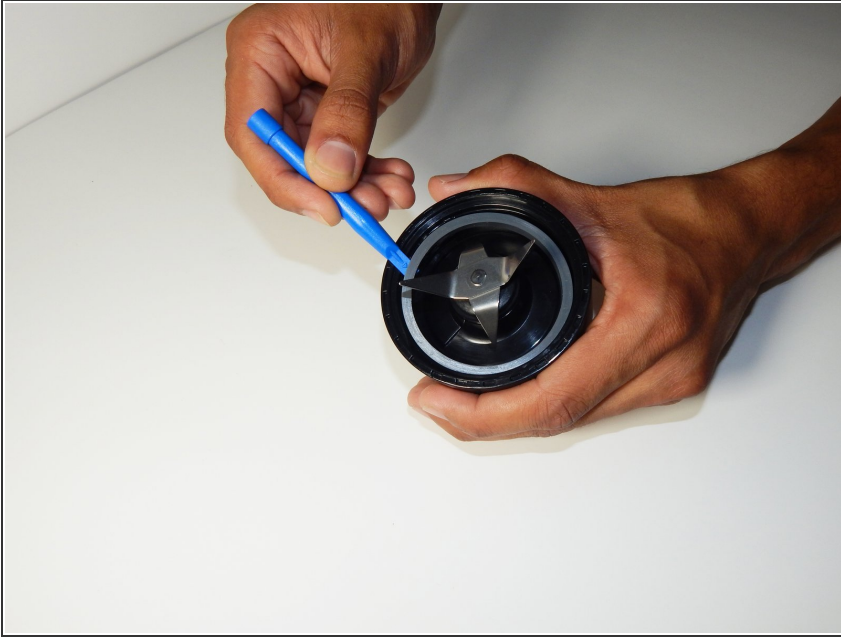
Step 4 — Blade Assembly Seal

- After separating the blade assembly from the blender bottle, position the plastic opening tool on either side of the seal in the blade assembly.
- Wedge tool between seal and seal seat wall.

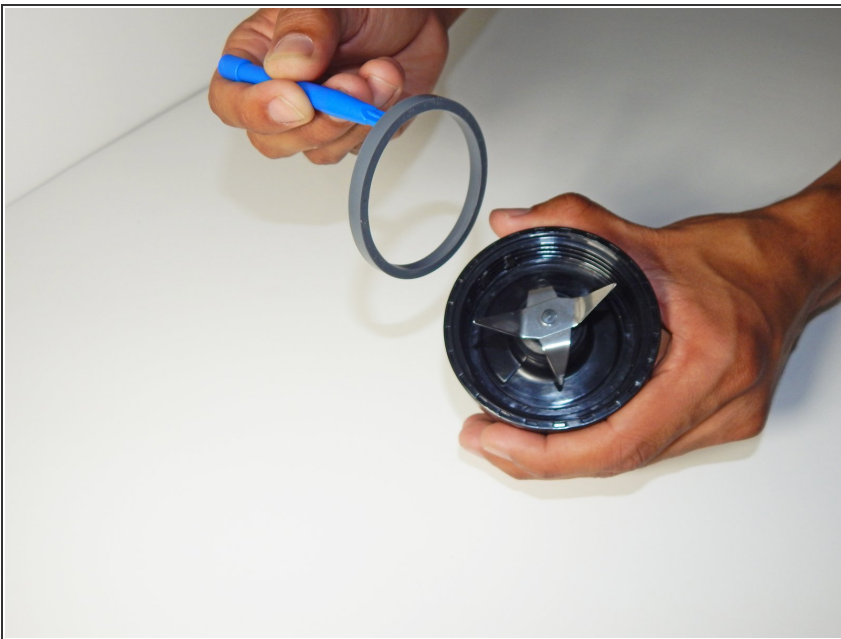
Step 5

- Gently pry the seal up while lifting seal out of the seal seat.

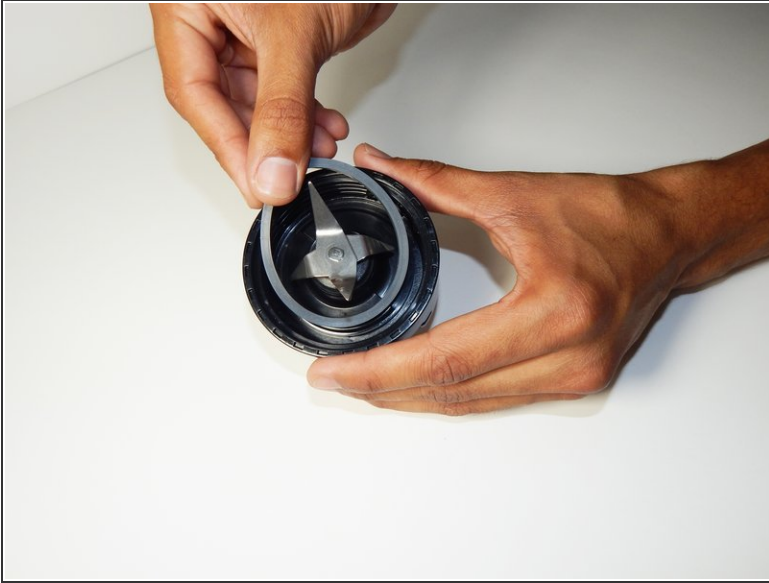
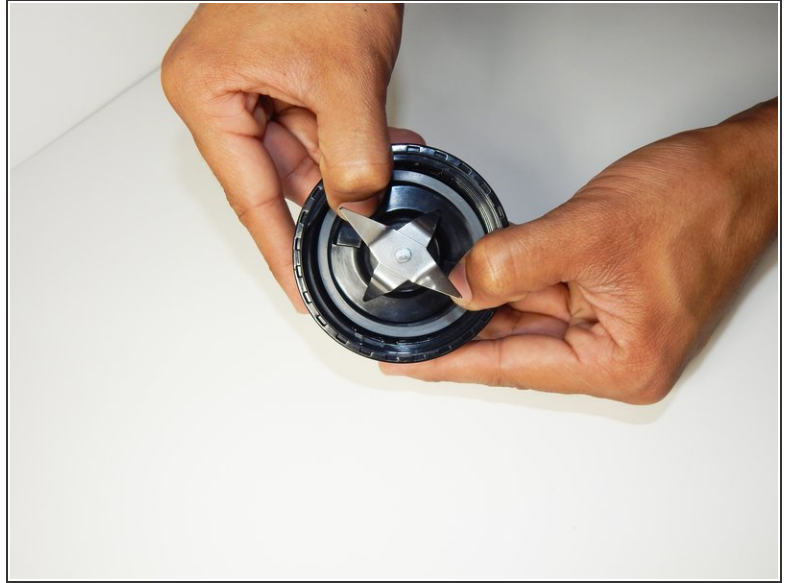
Step 6

- Place and press the new seal into seal seat with finger.
