Pododent Motor NSK Japan Bearing Replacement

Written By: Michael

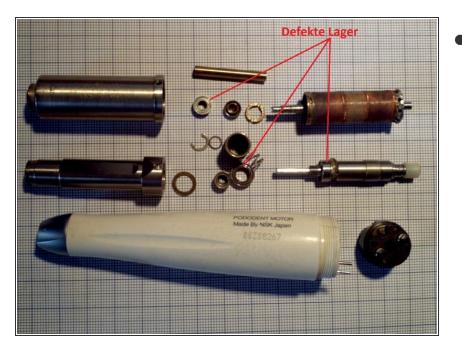
Step 1 — ball-bearing

The picture shows the items. In the handpiece are the motor housing with the top right anchor.

Underneath, on the right, is the clamping body for the tools and to the left thereof the receptacle of the clamping body. The engine is to take after replacement of the ball bearings about 350mA at 24 volts.
