# Amazon Fire 5th Generation Rear Camera Replacement

Use this guide to replace the rear-facing camera of the Amazon Fire 5th Generation.

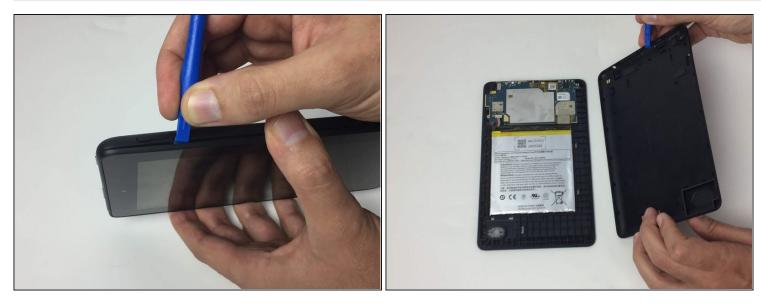
### Step 1 — Speaker

- (i) Ensure that your device is turned off.
- A Remove any micro-SD card that may be installed in the Fire. Failure to do so could damage the micro-SD card itself or the micro-SD card reader on the Fire.
- While holding the device firmly, wedge the iFixit Opening Tool into the crease along the outer edge of the device (as shown in the image).
- Slowly, grind the iFixit Opening Tool into the crease along the outer edges of the device until the entire back cover loosens.
- Then, remove the back cover from the device.

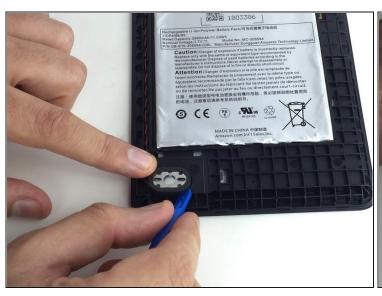
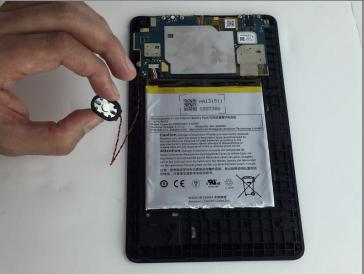
- Pry the speaker from the case using the iFixit Opening Tool.
- Lift the speaker up from the device to remove the speaker wires from their groove in the case.

$\triangle$  Be careful not to pull the speaker wires from the motherboard.

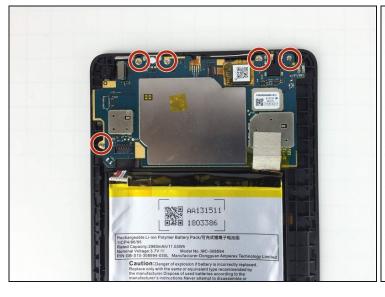
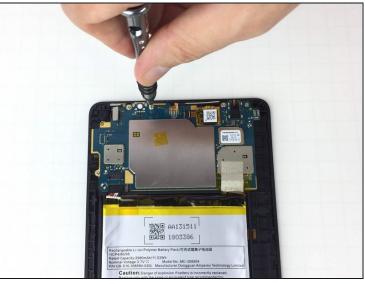
- Use a PH0 size Phillips screwdriver head to unscrew the five 2 mm screws on the motherboard. These screws are circled with red in the given image.
- Ensure that you keep track of these screws once removed.

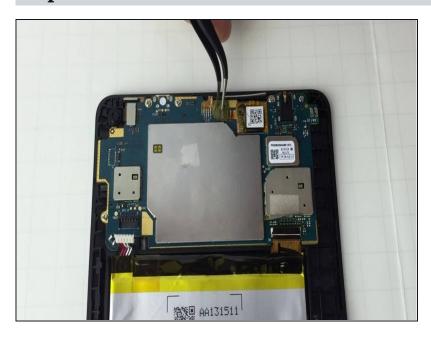
- The LCD Digitizer on the Amazon Fire tablet has a locking cable connector that holds it in place on the motherboard.
- To remove the cable, use the iFixit Opening Tool to unlock the LCD Digitizer cable connector.
- Once the wire connector is removed, use the iFixit
   Opening Tool to pry the entire
   LCD Digitizer away from the motherboard.
- (i) Remove any tape that may be covering the connector.

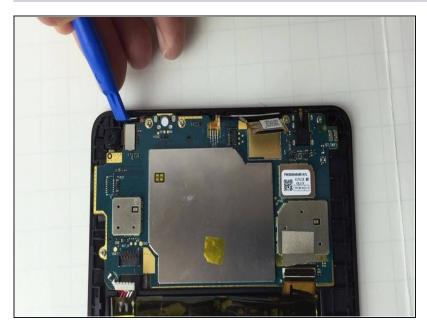
- The volume and power buttons must both be repositioned in order to remove the motherboard.
- To reposition the power and volume buttons, use the iFixit Opening Tool to pull the plastic casing upwards. Then, remove the casing completely.
- i Make sure that both the volume and the power buttons are free from the plastic casing before separating the motherboard from its case.
- ⚠ Be very careful when repositioning the volume buttons, since the fragile digitizer ribbon cable runs from the motherboard to the digitizer right next to the volume buttons. It is very easy to damage the ribbon cable while working in this area.

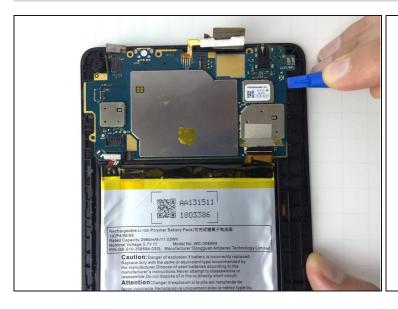
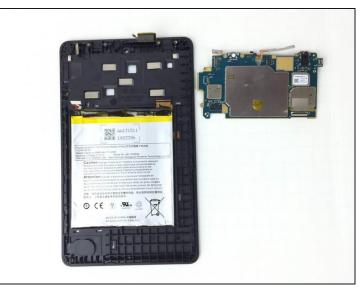
# Step 10

• Position the iFixit Opening Tool beneath the motherboard and pull upwards to remove the motherboard from its case.

⚠ Please handle the motherboard with gloves because skin oils can damage the connections on the board.

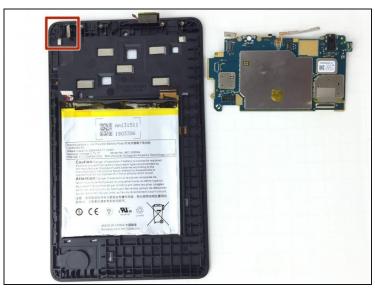
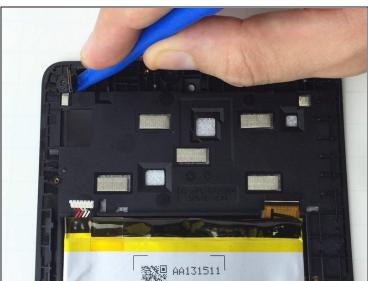
# Step 11 — Rear Camera

- The rear facing camera is directly attached with adhesive to the device case.
- In order to remove the camera, use a plastic opening tool to wedge underneath and lift it out of its place.
