# Philips Senseo II 7810 Coffee Maker - Capacitor on Printboard replacement

Consumers have encountered heating problems...

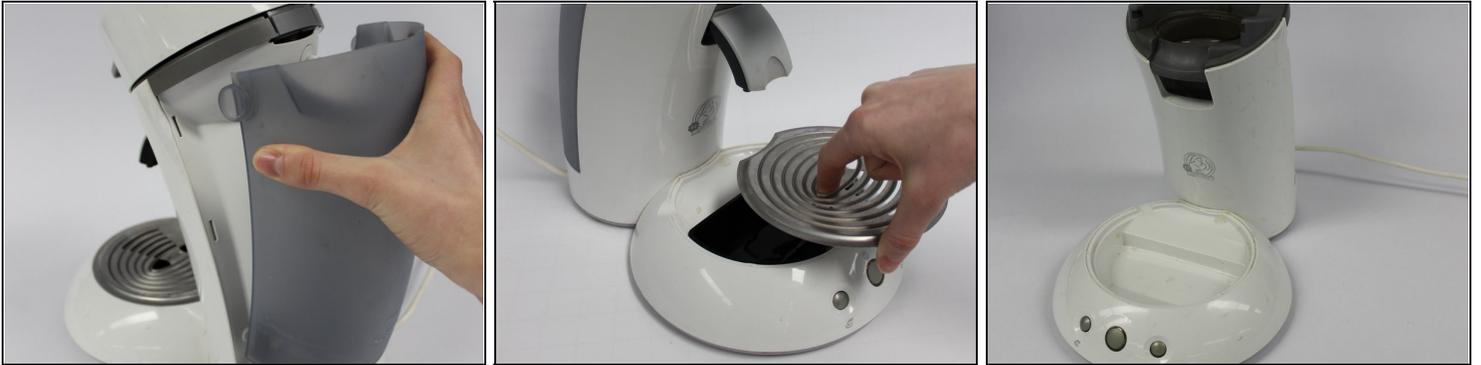
## Step 1 — Back Cover

- Remove the detachable components of the coffee maker:
  - unplug the product;
  - empty the water container and remove it from the coffee machine;
  - remove the cup tray and drip tray;
  - remove the pod holder and coffee outflow unit.

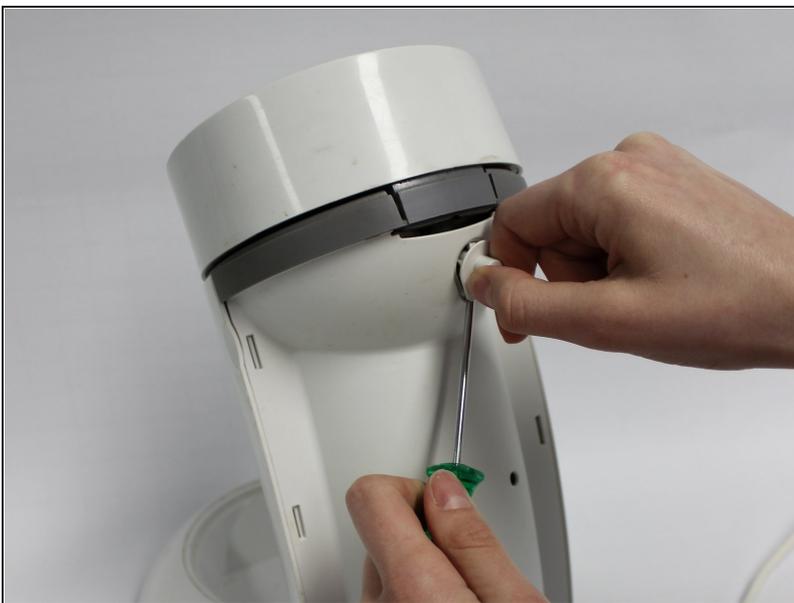
## Step 2

- Remove outflow valve by putting a flathead screwdriver in the gaps and use this as a lever.

**⚠ Pull gently while applying force.**

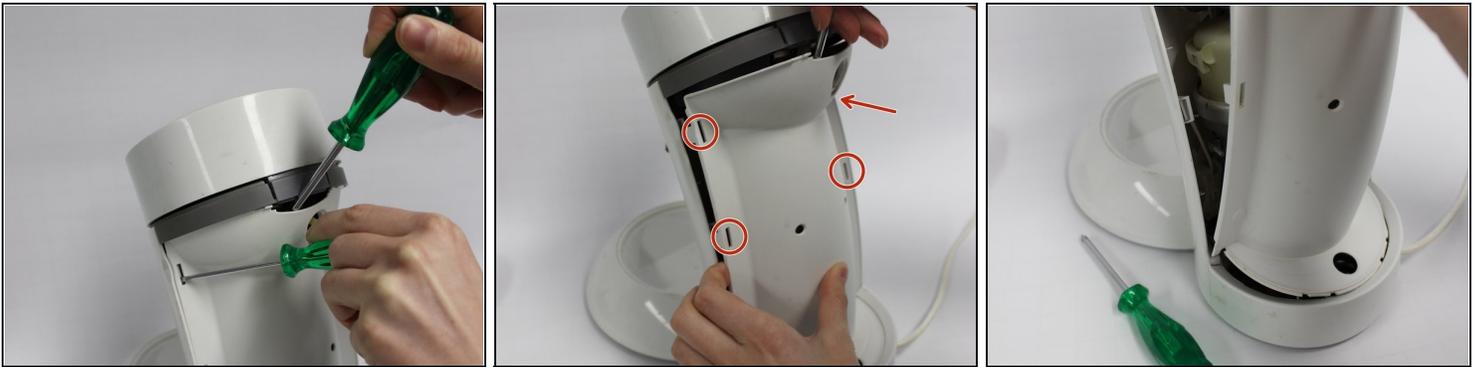
### Step 3

- Remove back panel by:
  - inserting (flathead) screwdriver in the top and pressing this against the snap-fit;
  - pressing screwdriver on left side against the snap-fit simultaneously;
  - rotating back panel whilst pressing against the snap-fits to loosen the panel until it is no longer connected on that side;
  - pressing screwdriver on right side against the snap-fit and removing back panel altogether.

⚠ Expect difficulty with pulling, more hands may be required.

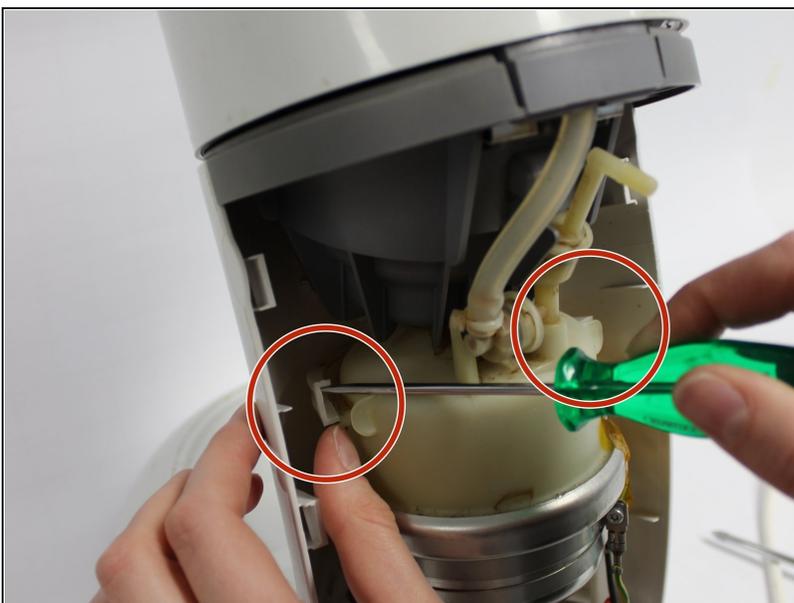
### Step 4 — Replacing the capacitor on printboard

- Remove side clamps to make the boiler accessible by pressing the plastic hooks (left and right) to the side.

⚠ When used prior to the disassembly, the boiler may still contain hot water!

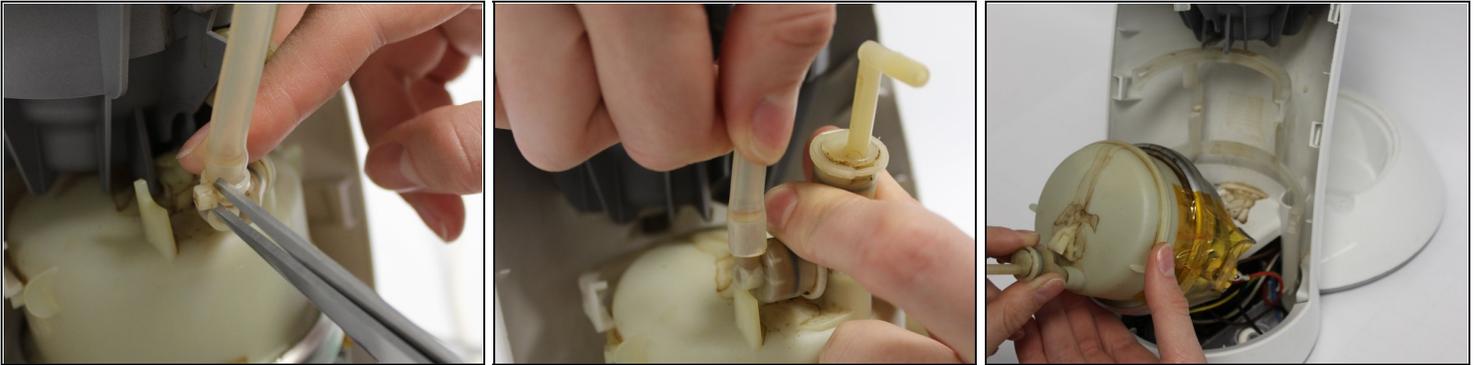
## Step 5

- Access the inner housing of the coffee maker by:
  - removing tie wrap from three-way valve with a pair of scissors;
- ⚠ Requires a lot of force.
- disconnecting the three-way valve from the hose. Beware of possible breaking of the bottom tube of the valve that is inside the boiler opening;
- ⚠ Difficulty with pulling, needs sculling.
- tilting the boiler, towards you (away from the inner casing).
- ⚠ When filled with (hot) water, beware of boiler leakage.

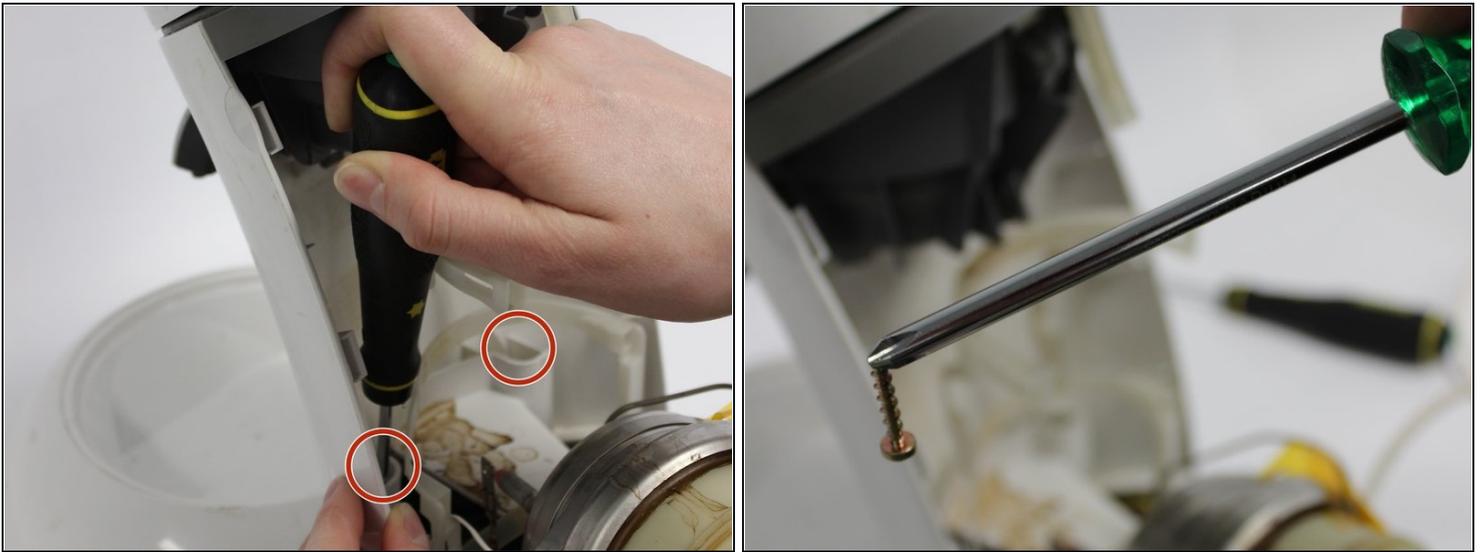
## Step 6

- Remove the 2 screws from within the housing, using a Torx T10 screwdriver.

☑ Tip: use the magnetism of a screwdriver to remove the screws from the housing.

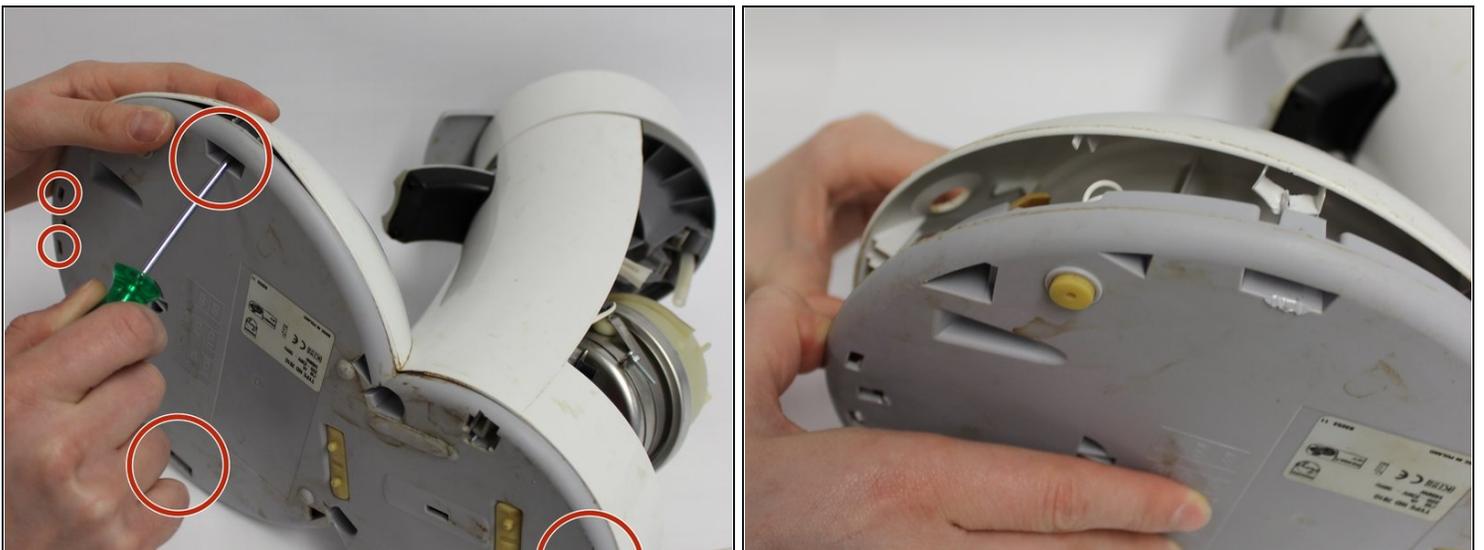
## Step 7

- Tilt the coffee machine and disconnect the bottom housing by pressing a flathead screwdriver against the snap-fit (CAUTION). There is a total of 6 snap-fits. (Two snap-fits at the rear are not visible in the picture)

⚠ Beware of not applying too much force when pressing snap-fits to avoid bending (and breaking) during the repair.

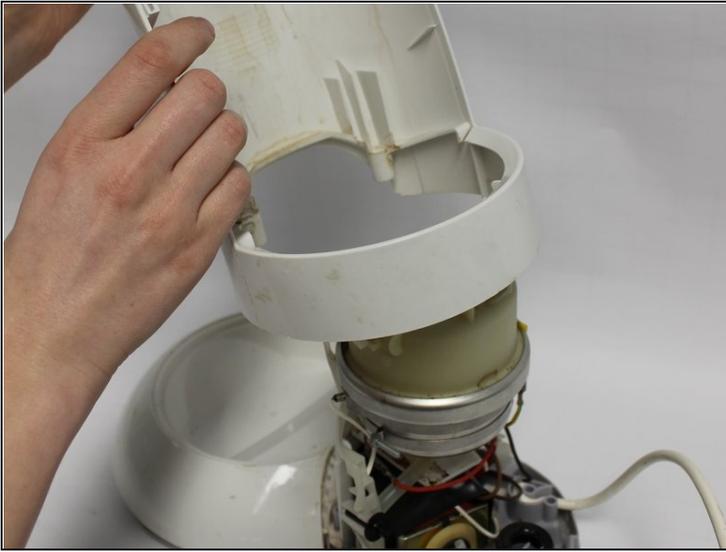
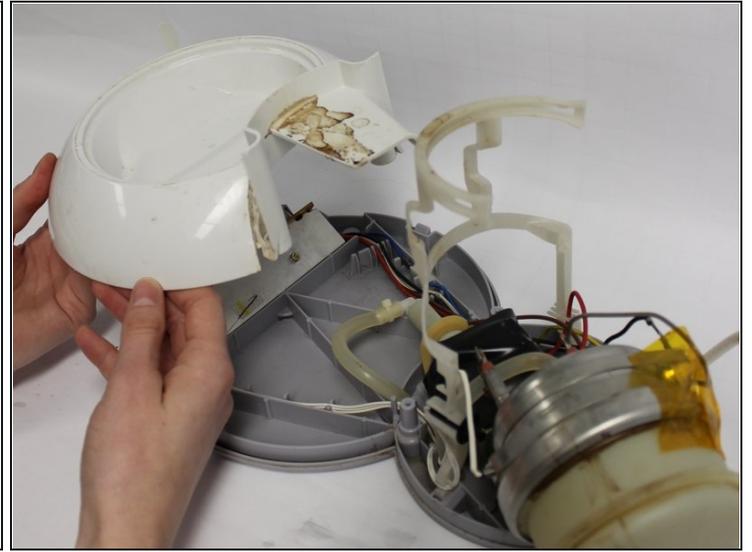
## Step 8

- Remove the cylindrical housing from the bottom housing.
- Remove the cup tray housing from the bottom housing.

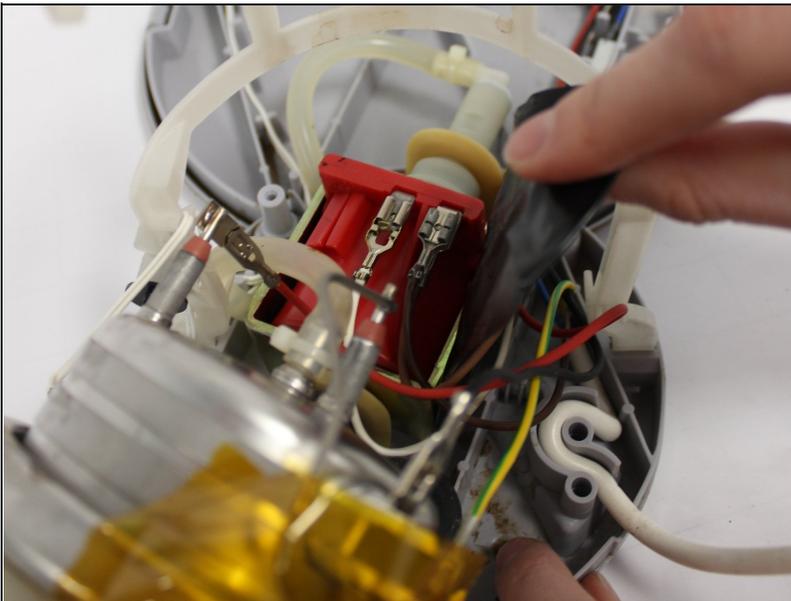
## Step 9

- Remove the tape from the red pump, by pulling.

⚠ Leaving the tape attached on the right side, enables re-using of the tape when reassembling.

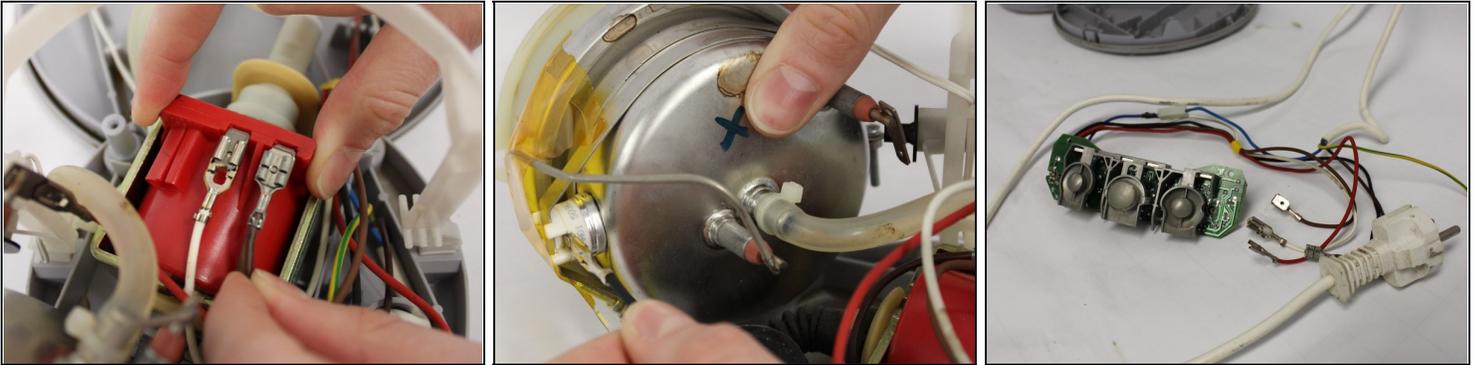
## Step 10

- Disconnect the two cables (white-brown) from the red pump by pulling gently. If the cables are hard to remove, carefully use flat nose pliers to pull the cables.

⚠ Remember the position of the cables for reassembling the Senseo machine. Marking the location and the cable with a different color marker, can be a solution.

- Disconnect the red, blue and green/yellow cables from the boiler.

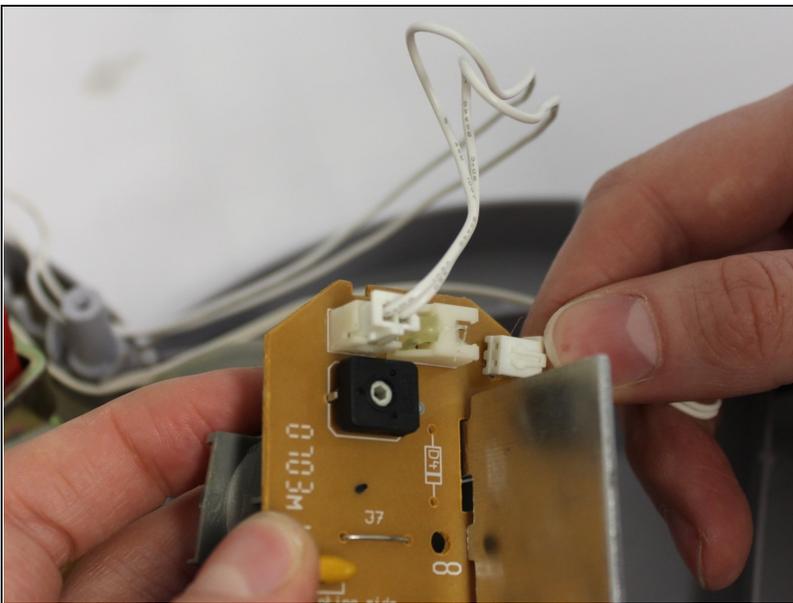
## Step 11

- Remove the two white cables, so the printboard (PCB) is no longer connected to the internal components.

⚠ Remember the position of the cables for reassembling the Senseo machine. Marking the location and the cable with a different color marker, can be a solution.

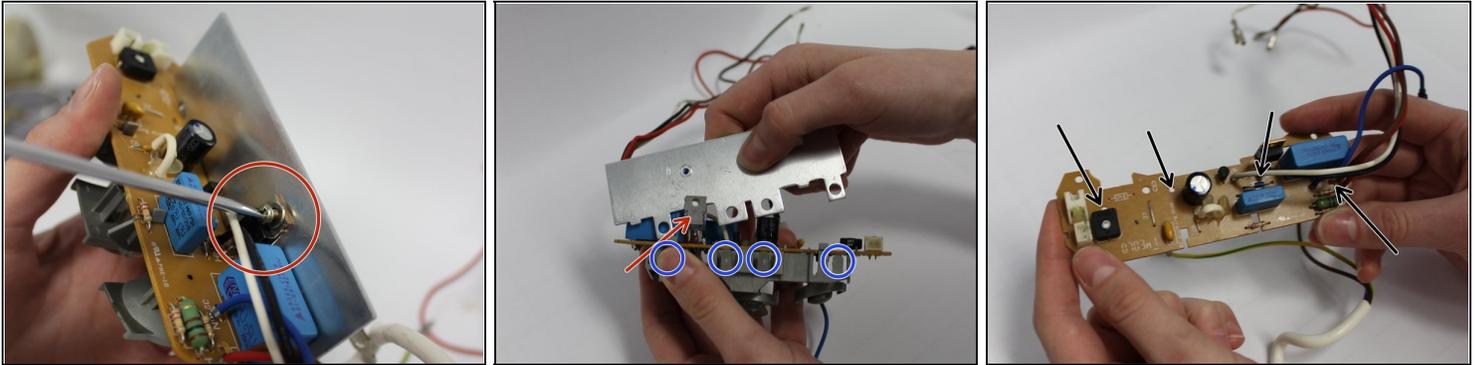
## Step 12

- Remove the nut from the plate against the PCB, using a Phillips screwdriver.

⚠ The order of loosening the snapfits now is important. First carefully press out (in an upward direction) four click fingers (from plastic buttons) that hold the plate in place, and then push out four pins in the PCB (holes marked with black arrows), which loosens the buttons. Beware of not affecting the transistor integrity when removing the plate.

- Remove the snap-fits of the PCB, so the plate and the PCB can be disconnected. Use a flathead screwdriver for punching and sculling.

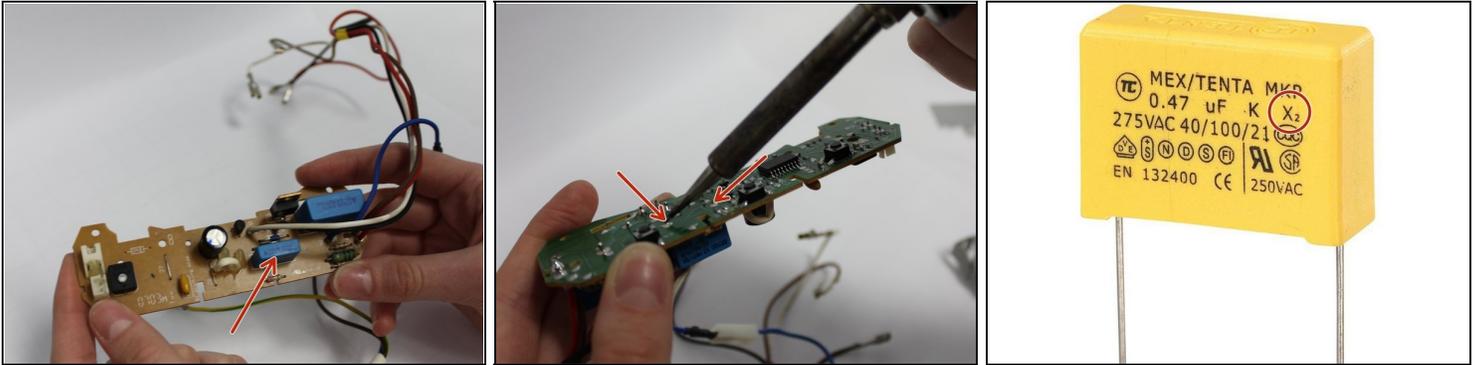
## Step 13

- ⓘ Obvious characteristics of a damaged capacitor are leakage of a brownish fluid, corrosion, or severed leads. Non-obvious signs could be measured with a capacity gauge (for the professional handyman).
- Search for the pegs of the capacitor on the PCB and warm up the soldering iron. Remember orientation (left-right)!
- ☑ The capacitor specification should be: 470nF, min. 275 VAC, 22.5 mm pitch. Only use X2-Class qualification which can be distinguished on the part. Capacitors come in blue and yellow colors.

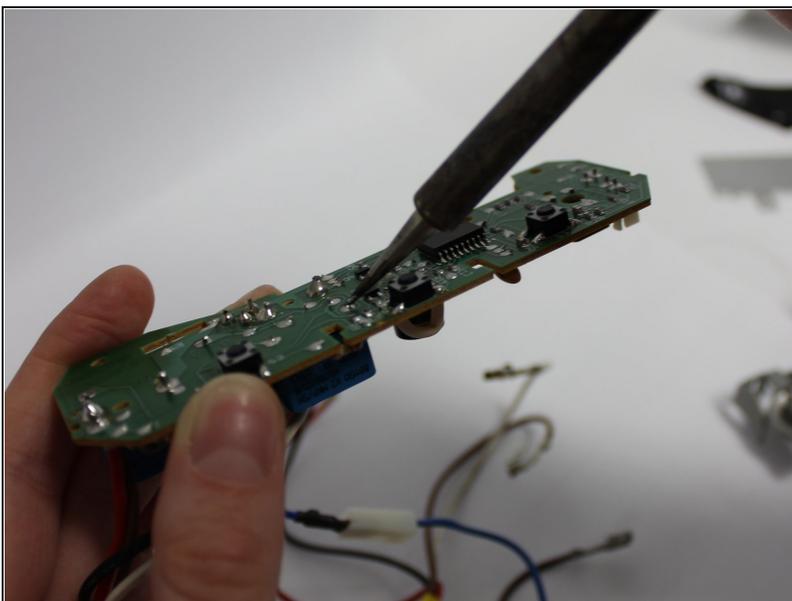
## Step 14

- Loosen the capacitor of the PCB, by desoldering the tin spots using the iron and remove the capacitor from the PCB.

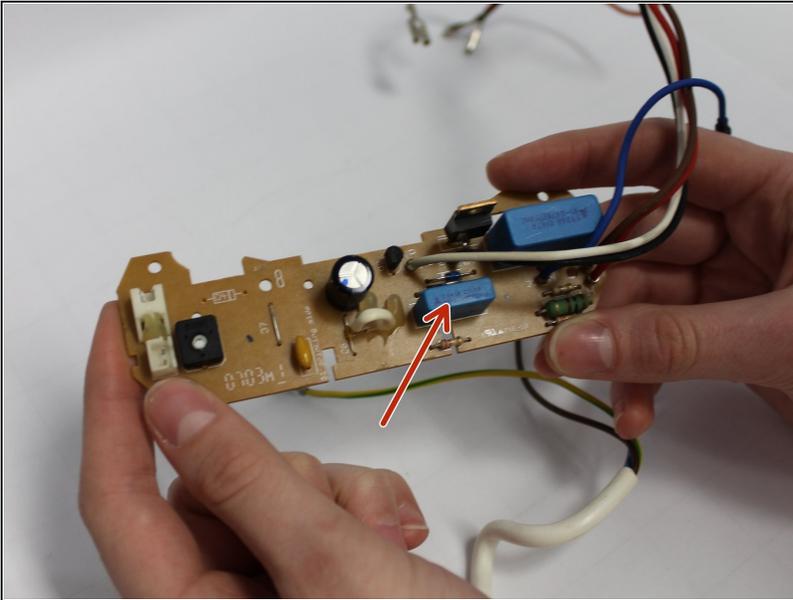
## Step 15

- Replace the capacitor by soldering a new capacitor of the same type on the exact same spot:
- scratch the green plastic of the printboard (with flathead screwdriver) to improve conductivity and cohesion;
- keep the capacitor on the right spot, hold the tin against the pegs of the capacitor and heat the tin with the soldering iron. The tin will cool down and the capacitor will be fixed.

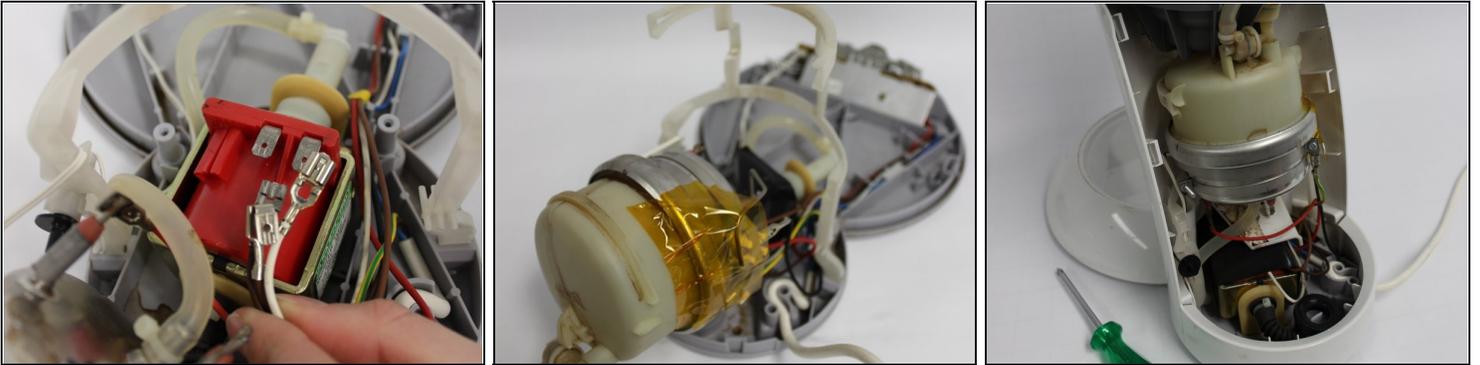
## Step 16

- Reassemble the Senseo coffee maker. The suggested actions during the disassembly should now help you greatly. Be careful with connecting wires (in the right way), tilting and reconnecting the boiler, and closing the housings and snap-fits.
- ☑ Tip: by following the previous 15 steps in reverse order, reassembly should take 15 minutes.
